Fall Vegetation Survey Report
in 08/09/10/11-29-20 W4M and 20/29-28-19 W4M
Resiliency and Flood Mitigation Program

Drumheller Resiliency and Flood Mitigation Office
Drumheller, Alberta

Applied Aquatic Research Ltd.
Calgary, Alberta

FINAL
January 2021
AAR Project: 20-105

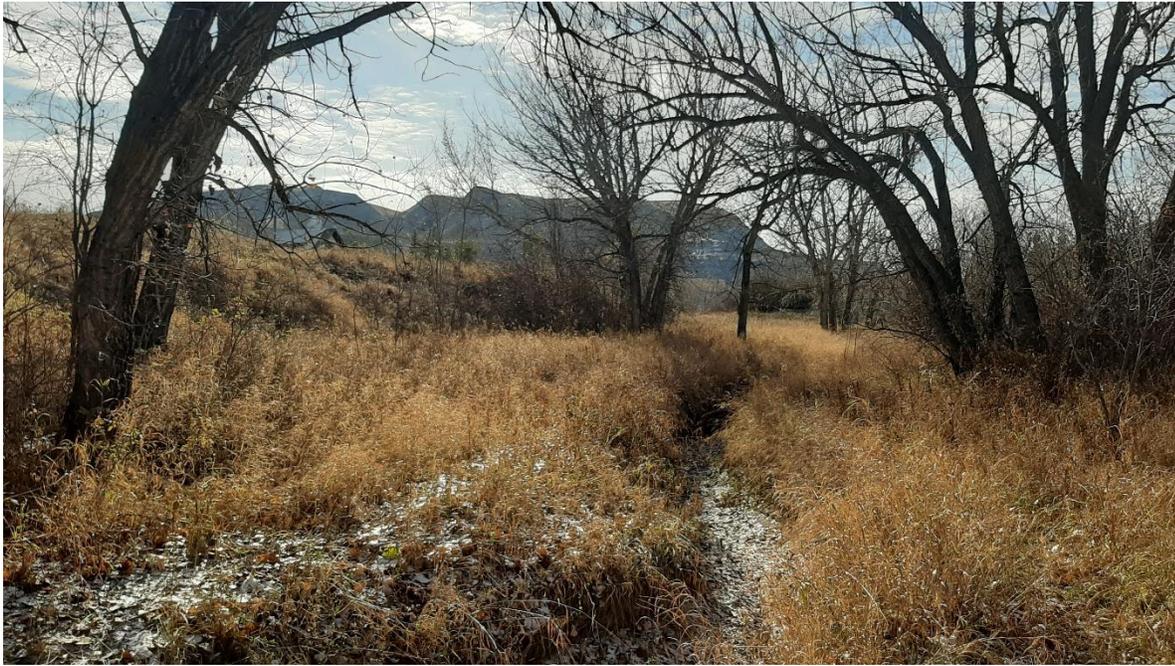
Plate 1. Nacmine. West bank of the proposed construction footprint (October 20, 2020).

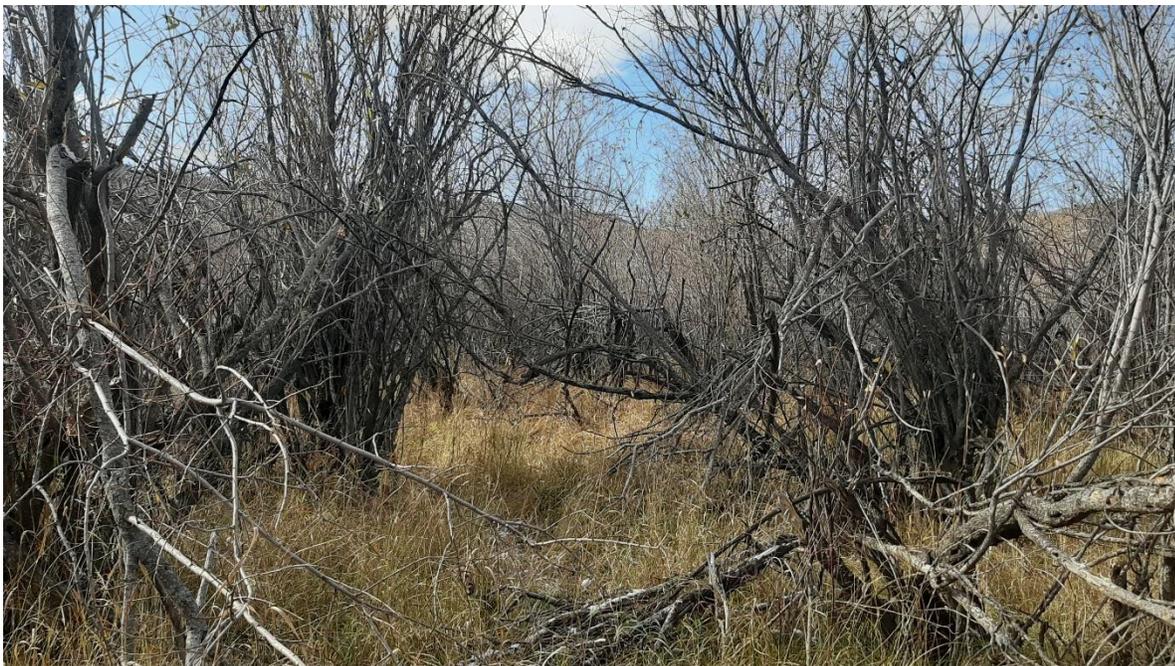
Plate 2. Nacmine. Seasonal wetland. (October 20, 2020).

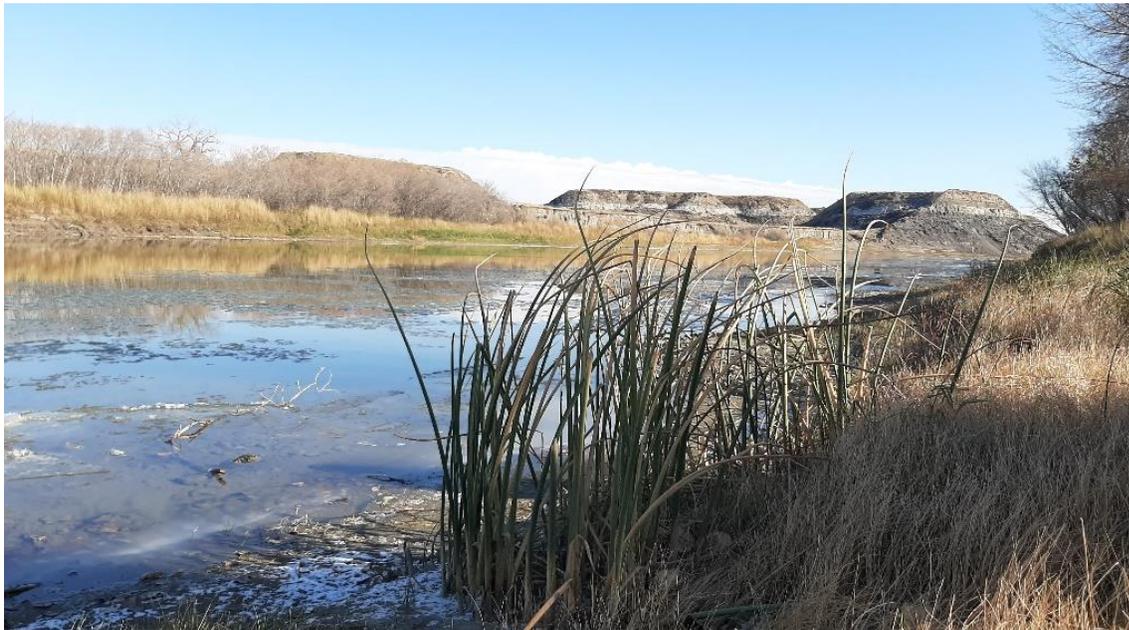
Plate 3. Nacmine. Shoreline vegetation along river bank (October 20, 2020).

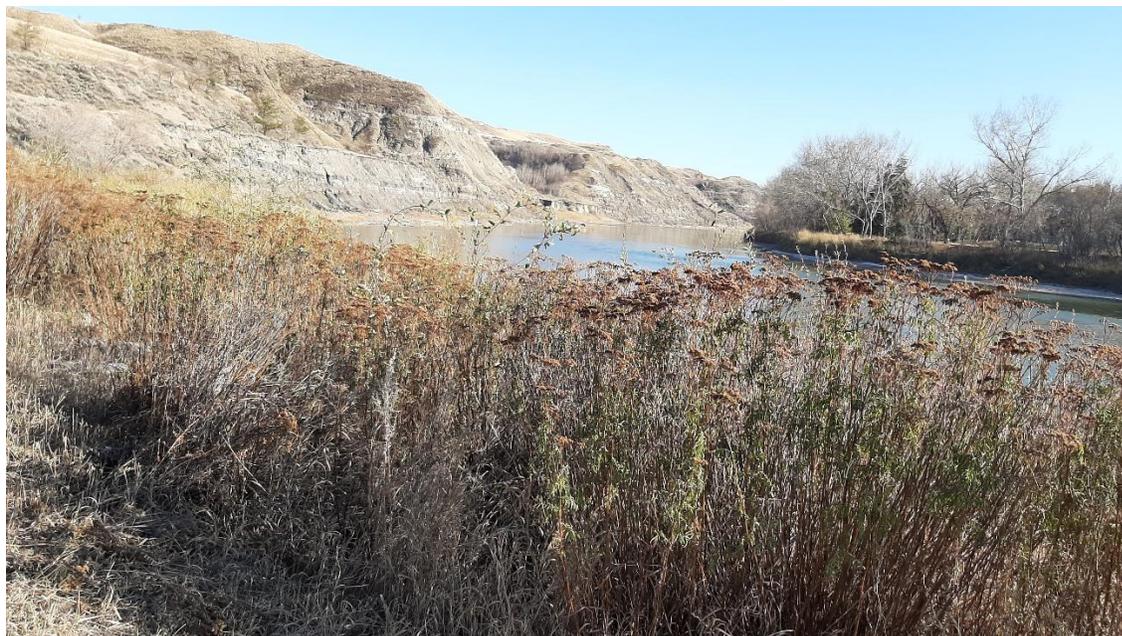
Plate 4. North Drumheller. The river bank of the Red Deer River (October 20, 2020).

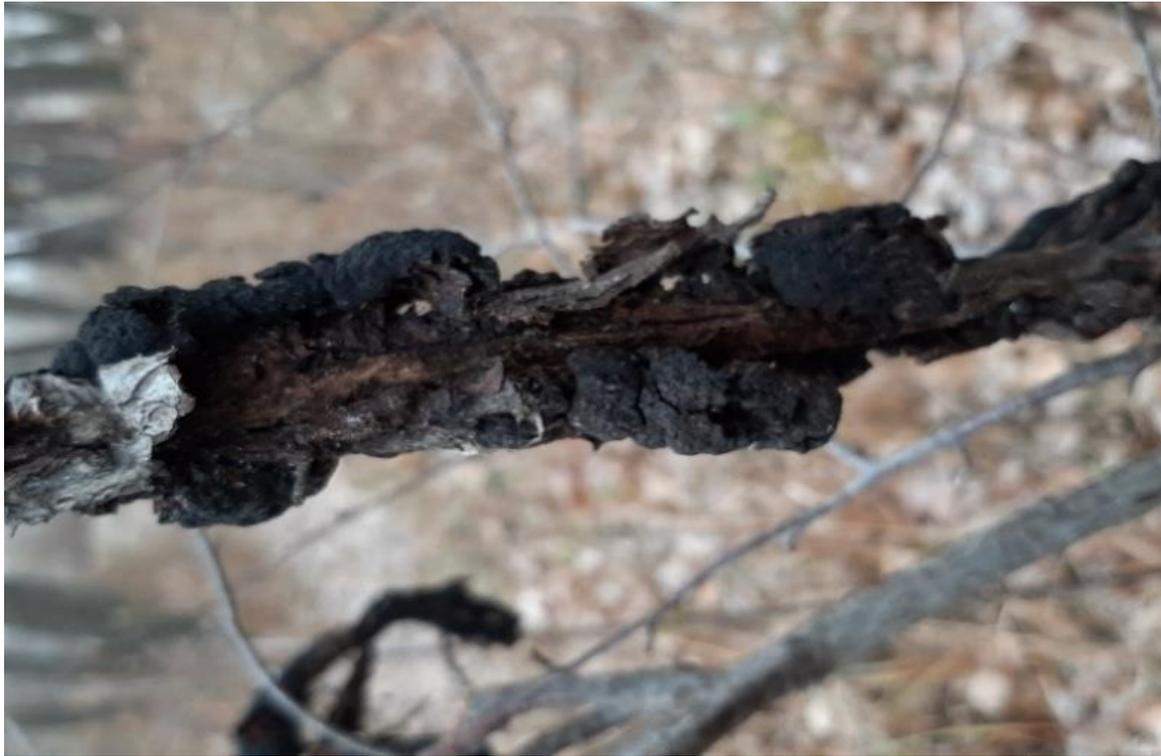
Several patches of the noxious weeds Canada thistle (*Cirsium arvense*) and common mullein (*Verbascum Thapsus*) as well as two ruderal species (foxtail barley (*Hordeum jubatum*) and common tansy (*Tanacetum vulgare*) were observed during the survey within close proximity of proposed construction areas. Black knot disease was observed on bark of young and mature trees along the north-west section of the Rosedale site (Plate 5).

Plate 5. Rosedale. Black knot disease (October 21, 2020).

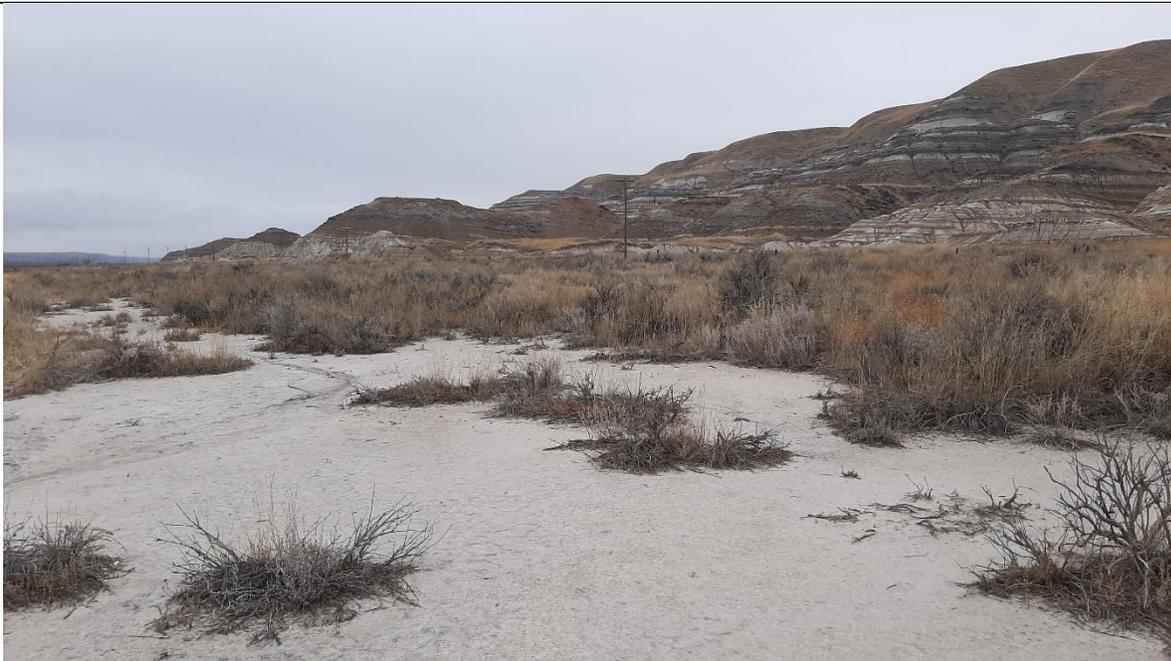
Plate 7. Hoodoo Trail. Sagebrush shrubland and fescue grasses spp. characterizing a typical habitat of Northern Fescue Natural Subregion (October 21, 2020).

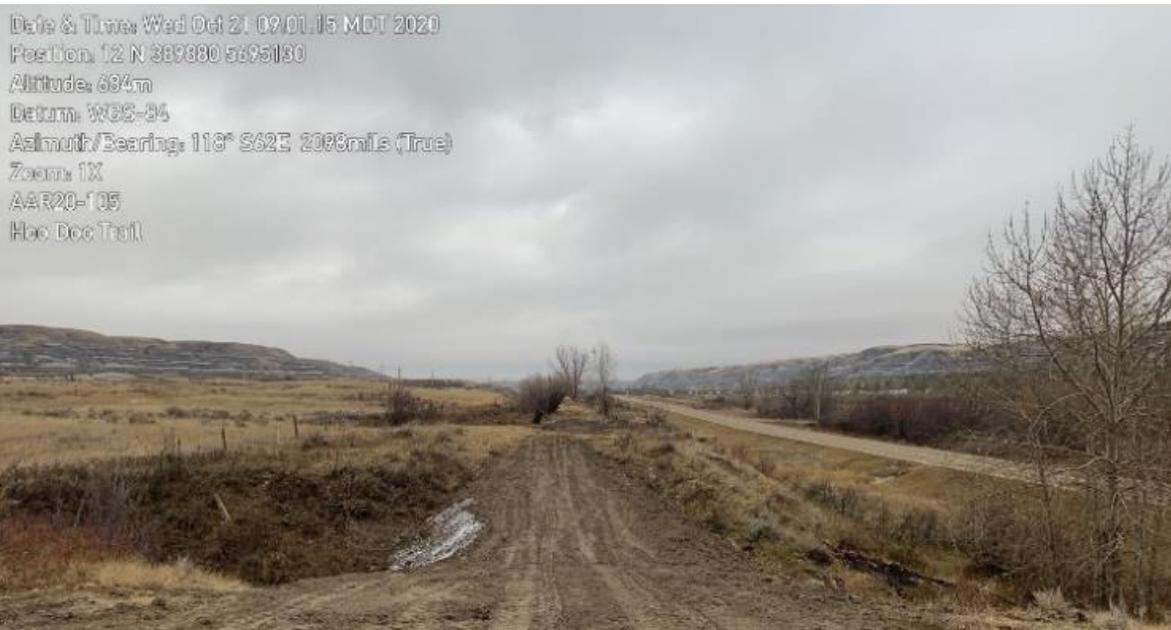
The Hoodoo Trail site (Figure 4) consisted of shrubs that covered about 35% and the remaining 65% represented ground floor and vegetation. The hoodoo trail is surrounded by a silver sagebrush shrubland and native and introduced grasses that are typical for Grassland Region (Plate 7). The site is within close proximity to Mixedgrass Natural Subregion and therefore can also have species representative to Mixedgrass habitat. At the time of survey, cleared vegetation areas, stripped topsoil and recent culvert installation were recorded along the route (Plate 8).

Plate 8. Hoodoos Trail. Recent vegetation clearing, stripping topsoil and culvert installation were recorded along the route (October 21, 2020).

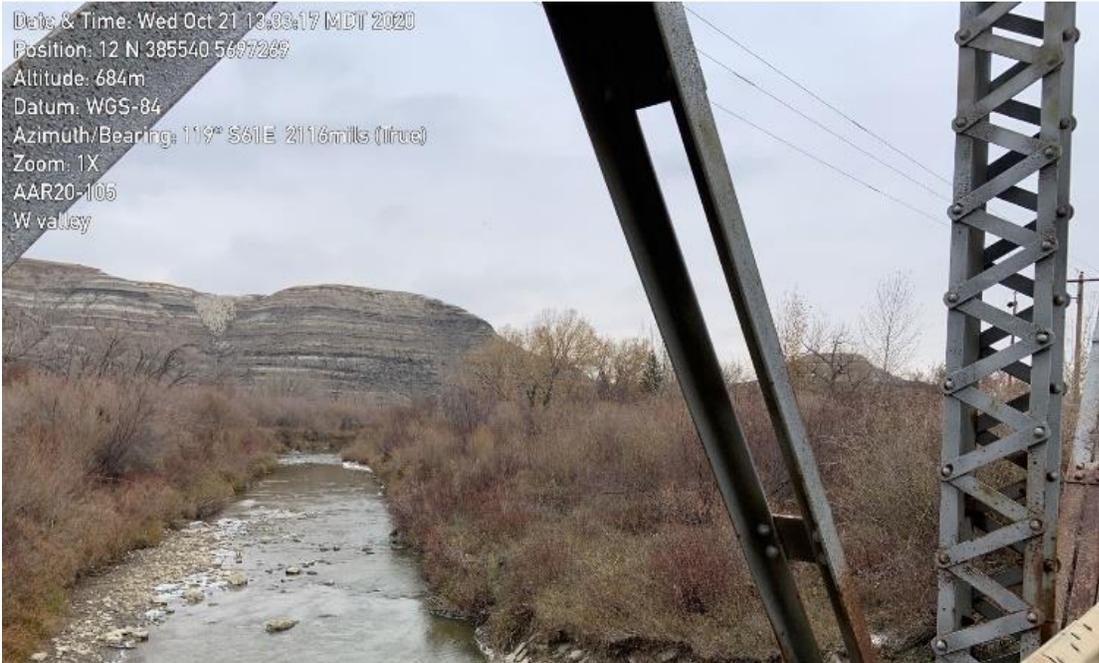
Based on the desktop assessment and visual assessment from the road, composition of vegetation and habitat types are expected to be similar to those found along the Rosedale footprint (Plates 9 and 10). Wayne Valley was not directly accessed due to landowner approval constraints at the time of on-site investigation.

Plate 9. Wayne Valley. West view of the Wayne Valley proposed construction area (October 21, 2020).

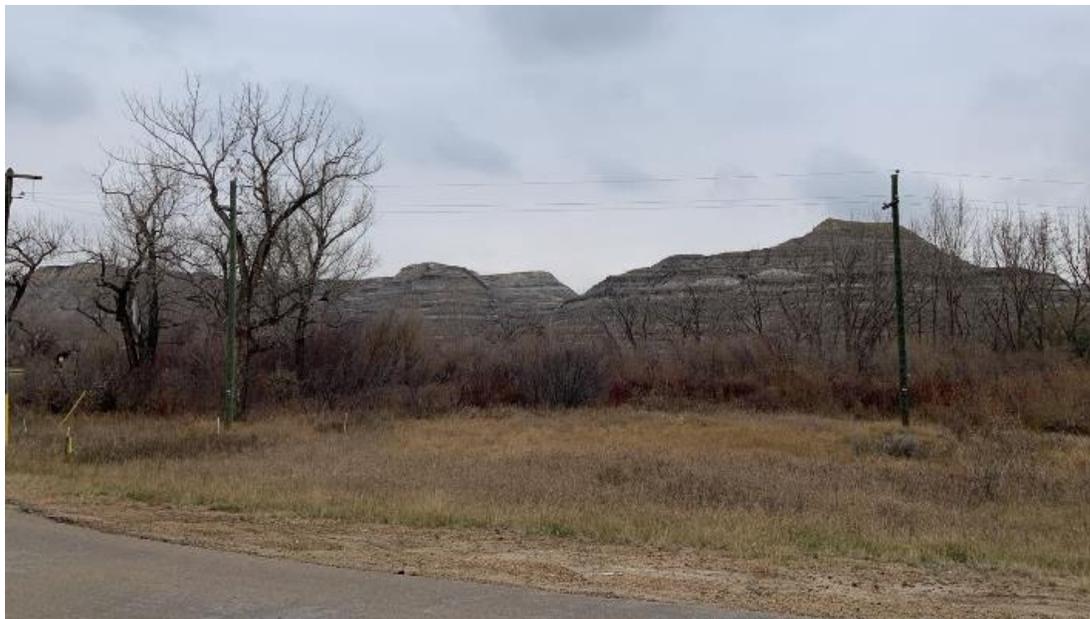
Plate 10. Wayne Valley. East view of the Wayne Valley proposed construction area (October 21, 2020).

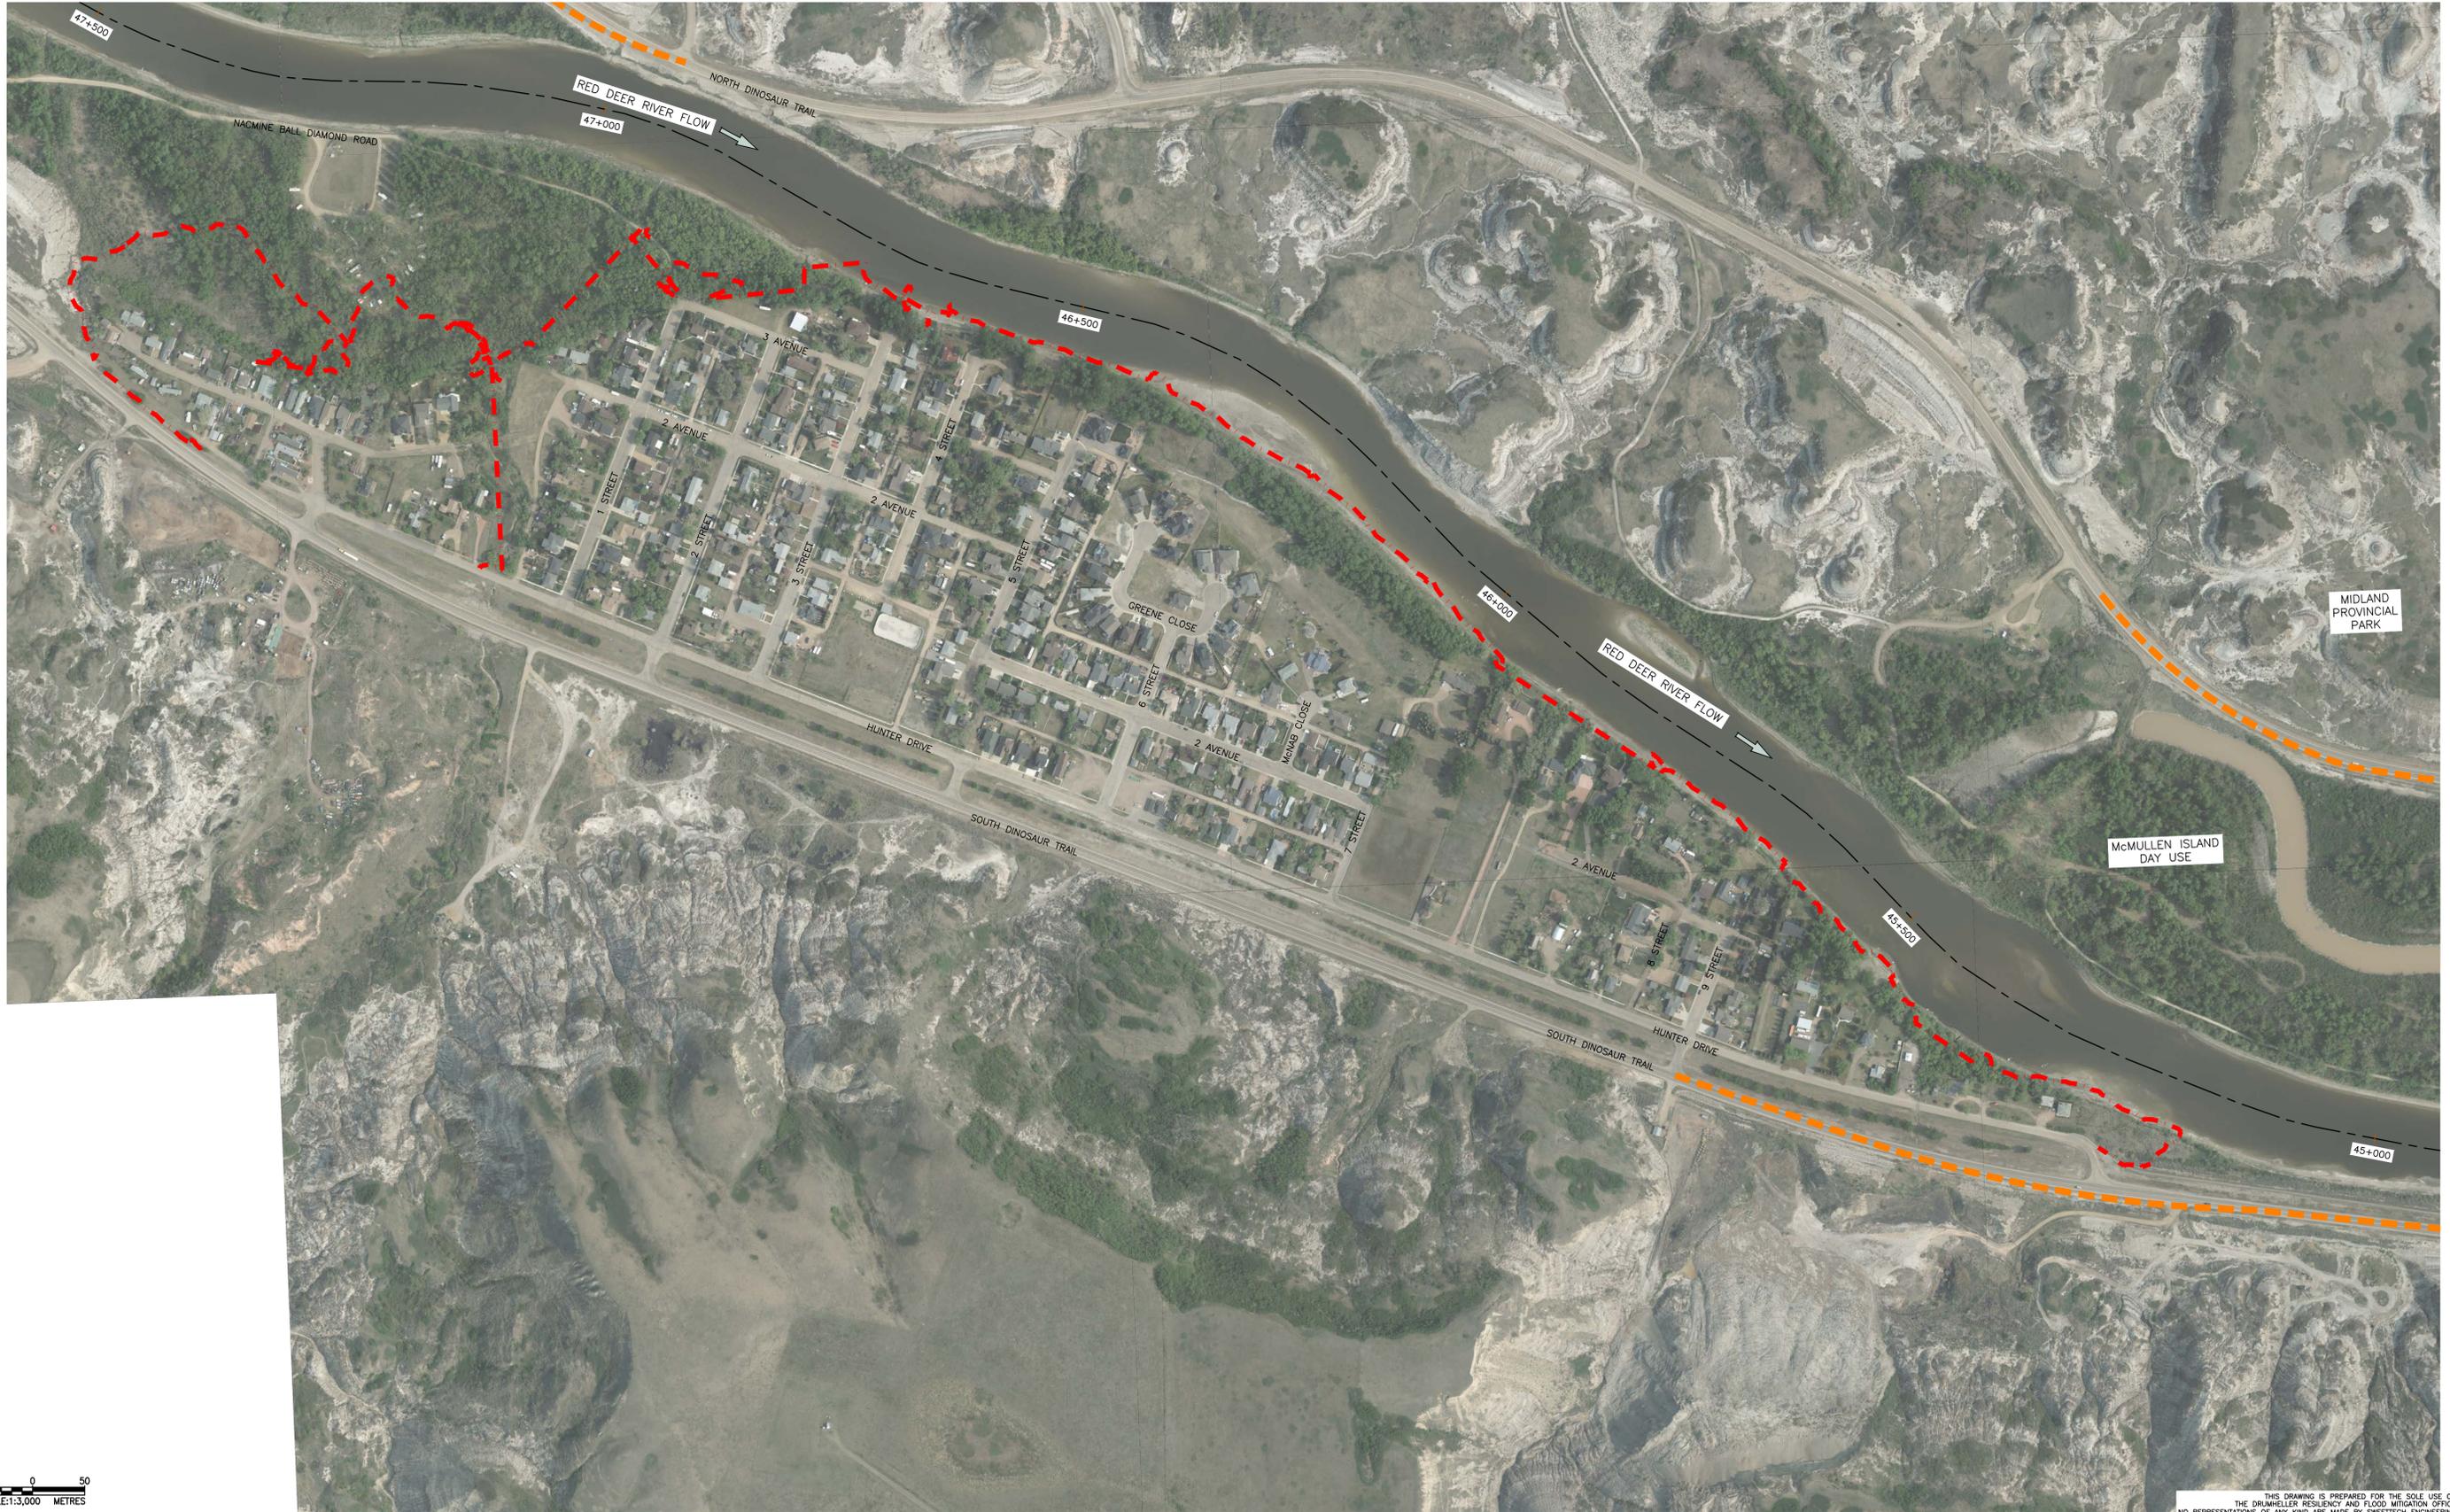
FIG.1 VEGETATION SURVEY ROUTE - NACMINE

The Nacmine location (Figure 1) had approximately 50% forest canopy cover; shrubs covered 30% and the remaining 20% represented ground floor and vegetation (Plate 1-3). Species largely consisted of mature deciduous trees (poplar and aspen species) with a shrub understory dominated by willows and wild and prickly rose. The western portion of the route followed the bank of the Red Deer River (Plate 3) with vegetation typical of prairie region riparian habitat (willows, sages, rushes, horsetail, and cattail) although unsurprisingly, considering the proximity to houses and disturbance, ruderal vegetation and weed species were also observed, notably Canada thistle, foxtail barley, and common tansy. The eastern and south-eastern portions of the route follow the south bank of the Red Deer River; a mix of shrubs and mature trees are found along the route. Seasonal wetlands (Plate 2) and river bank shoreline consisted of wetland vegetation: horsetail, sedges, rushes and common cattail.

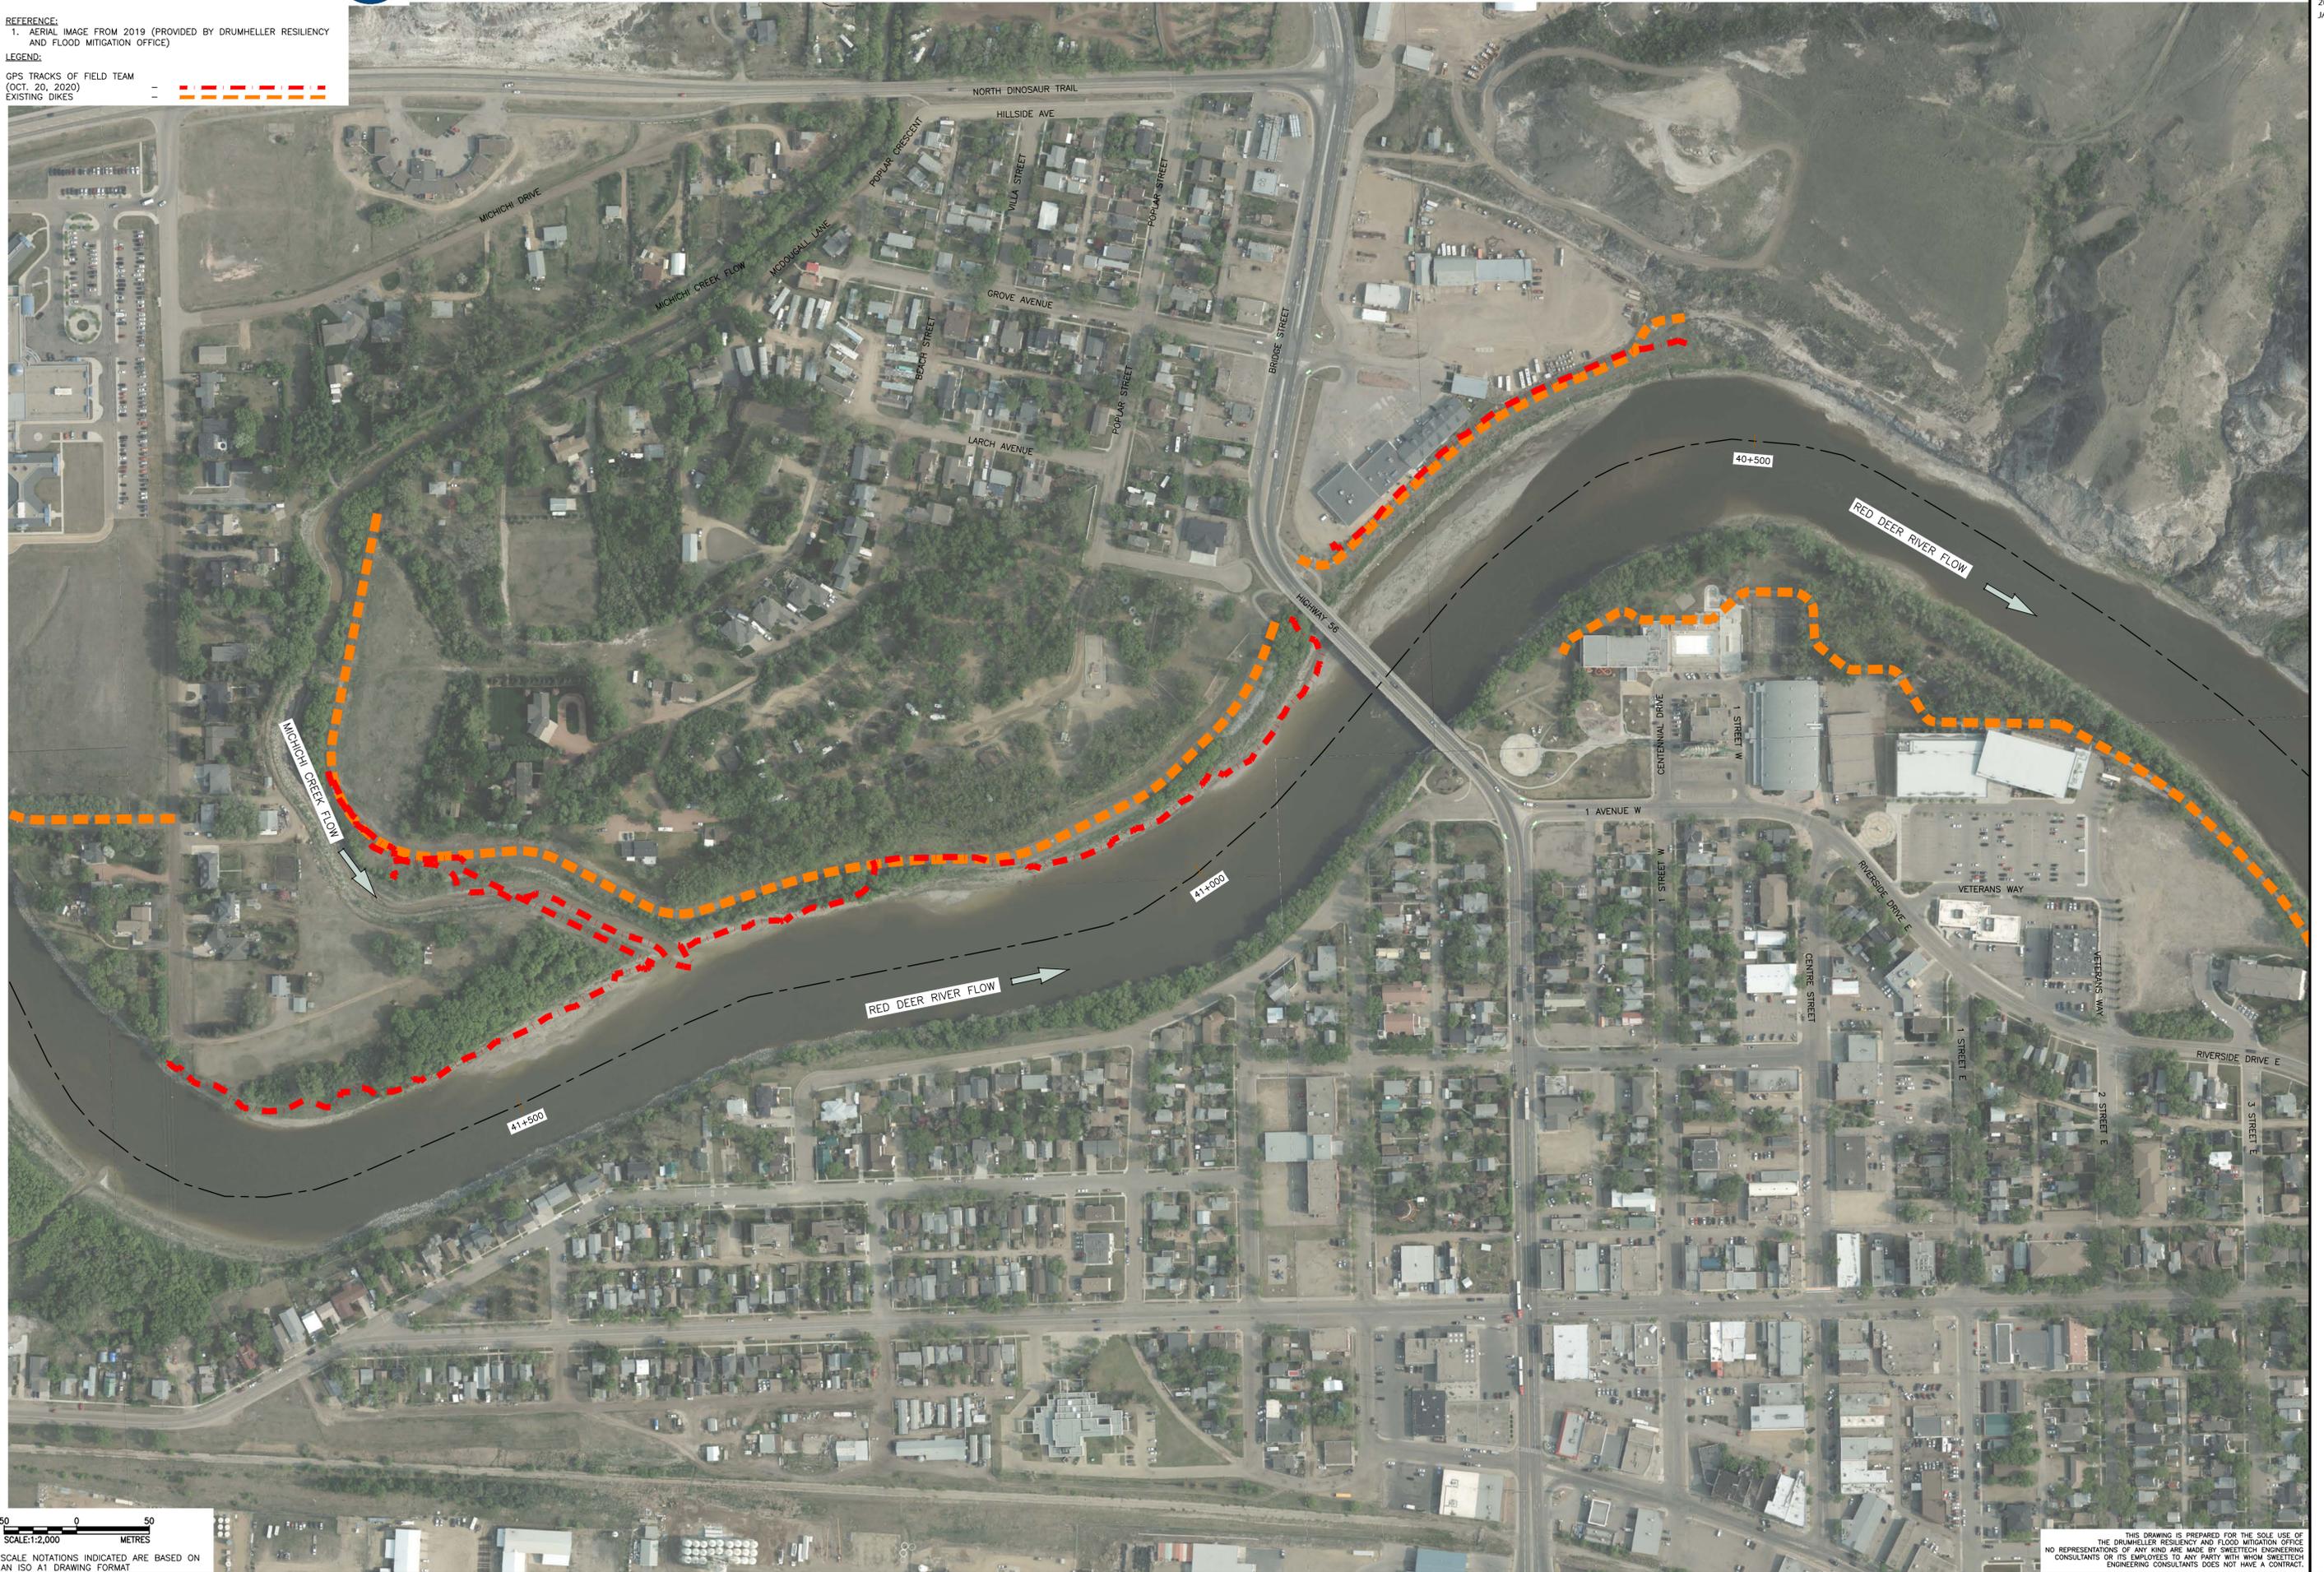
FIG.2 VEG. SURVEY ROUTE - NORTH DRUMHELLER

The Northern Drumheller site had approximately 30% forest canopy cover; shrubs covered 40% and the remaining 30% represented ground floor and vegetation (Figure 2). North Drumheller routes follow the north bank of the Red Deer River through a residential area of the Town of Drumheller (Plate 4). The west bank has been stabilized previously with concrete pieces and boulders. Vegetation is similar to Nacmine, consisting of riparian species with large mature deciduous trees (aspen and poplar) and shoreline vegetation. Proximity with residential areas and recent construction activity have undermined integrity of native vegetation since soils have been disturbed. As the result low-quality habitat with ruderal and noxious species such as Canada thistle were observed.
