Drumheller Resiliency and Flood Mitigation Program

Fish and Fish Habitat Assessment

A03409A01

December 2020

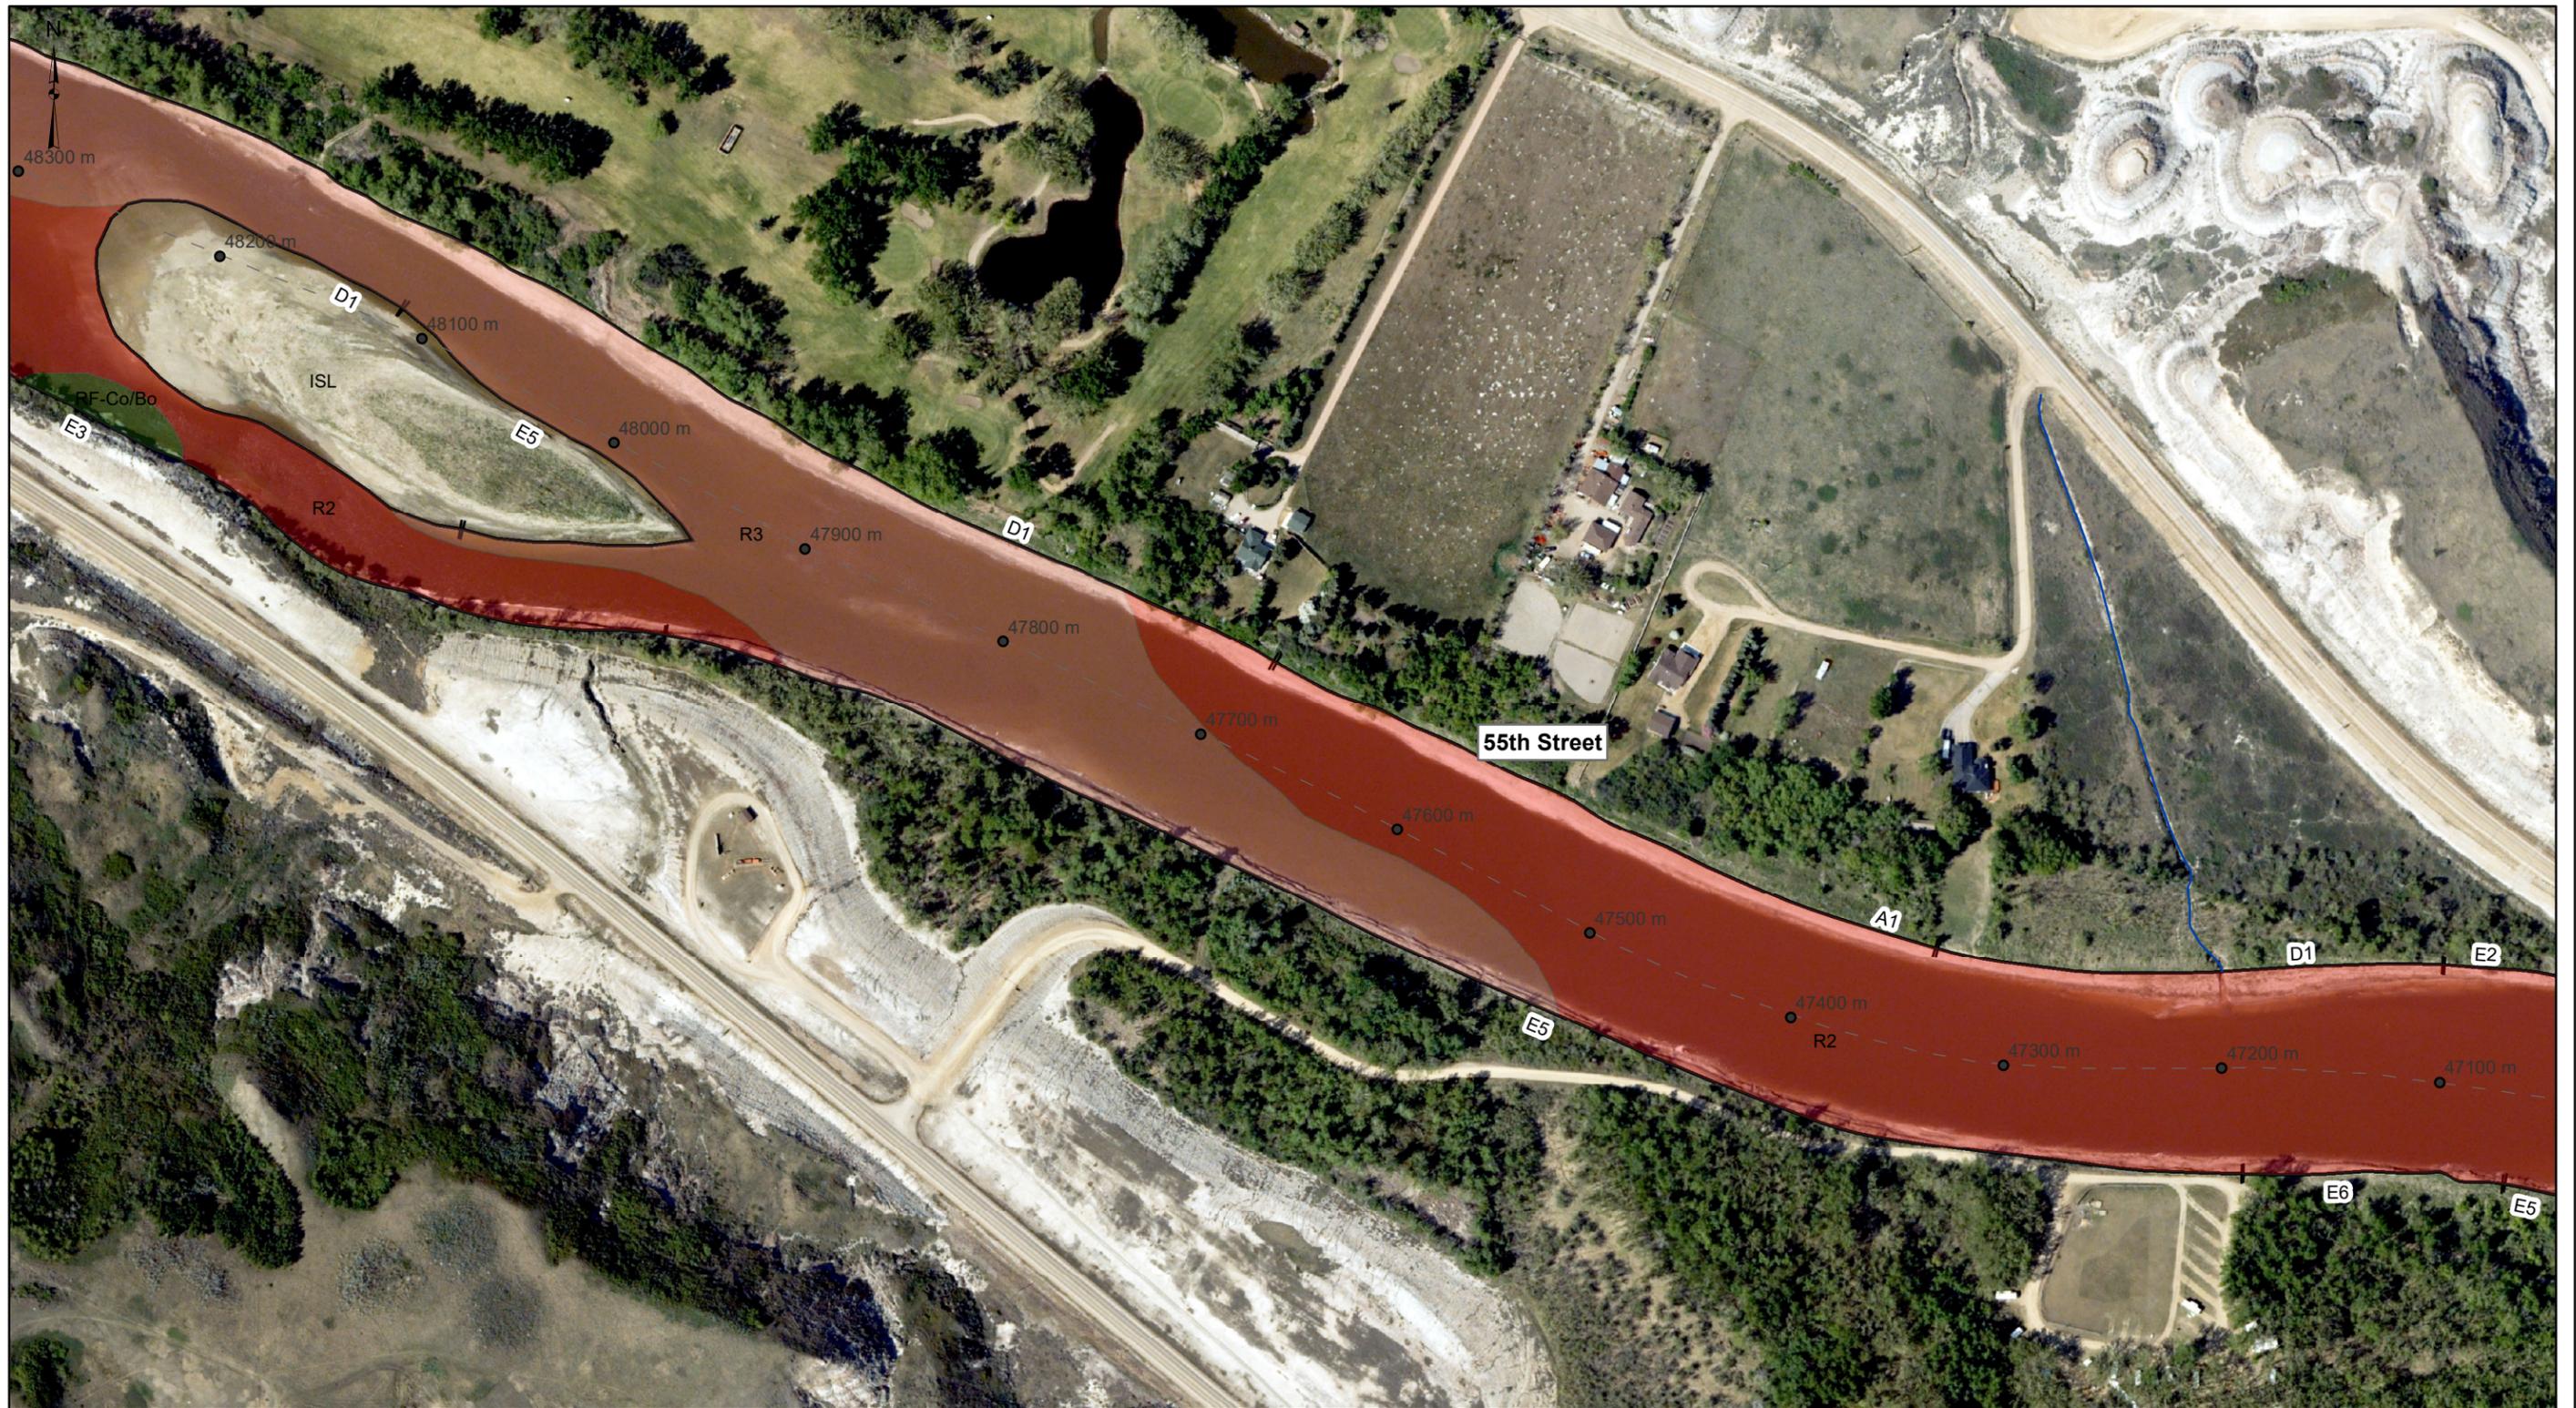
PROJECT DRUMHELLER RESILIENCY AND FLOOD MITIGATION PROGRAM FISH AND FISH HABITAT ASSESSMENT		
TITLE Fish Habitat Map - Detail (Sheet 1 of 11)		
SCALE 1:3,000	PROJECT No. A03409A01	FIG No. 2

The habitat within the upstream portion of the Study Area extending from the 55th Street reach to the Midland reach was characterized by shallow to moderate depth runs with a varied bottom profile providing infrequent pockets of riffle and backwater habitat (Figures 2-4) (Appendix I: Photographs 1-3). While banks in this stretch were predominantly characterized as low depositional or erosional and providing limited cover, a few sections of erosional bank did provide cover from overhanging vegetation and slumped bank material. Islands, as well as mid and side channel bars comprised of gravels were infrequent through this section of the Study Area. Natural bank armoring was noted infrequently within this portion of the Study Area, including one bank section directly adjacent to the 55th Street reach (Figure 2) (Appendix I: Photograph 2). At this location the left (north) bank had a gentle slope down from a stepped floodplain terrace, with natural armoring of cobbles (A1) at the bank toe. Gently sloping depositional bank habitat (D1) occurred upstream and downstream along the reach. No vegetation or debris occurred along the bank within the reach, with limited cover provided by coarse substrate at the toe. The adjacent instream habitat was a moderate depth run.

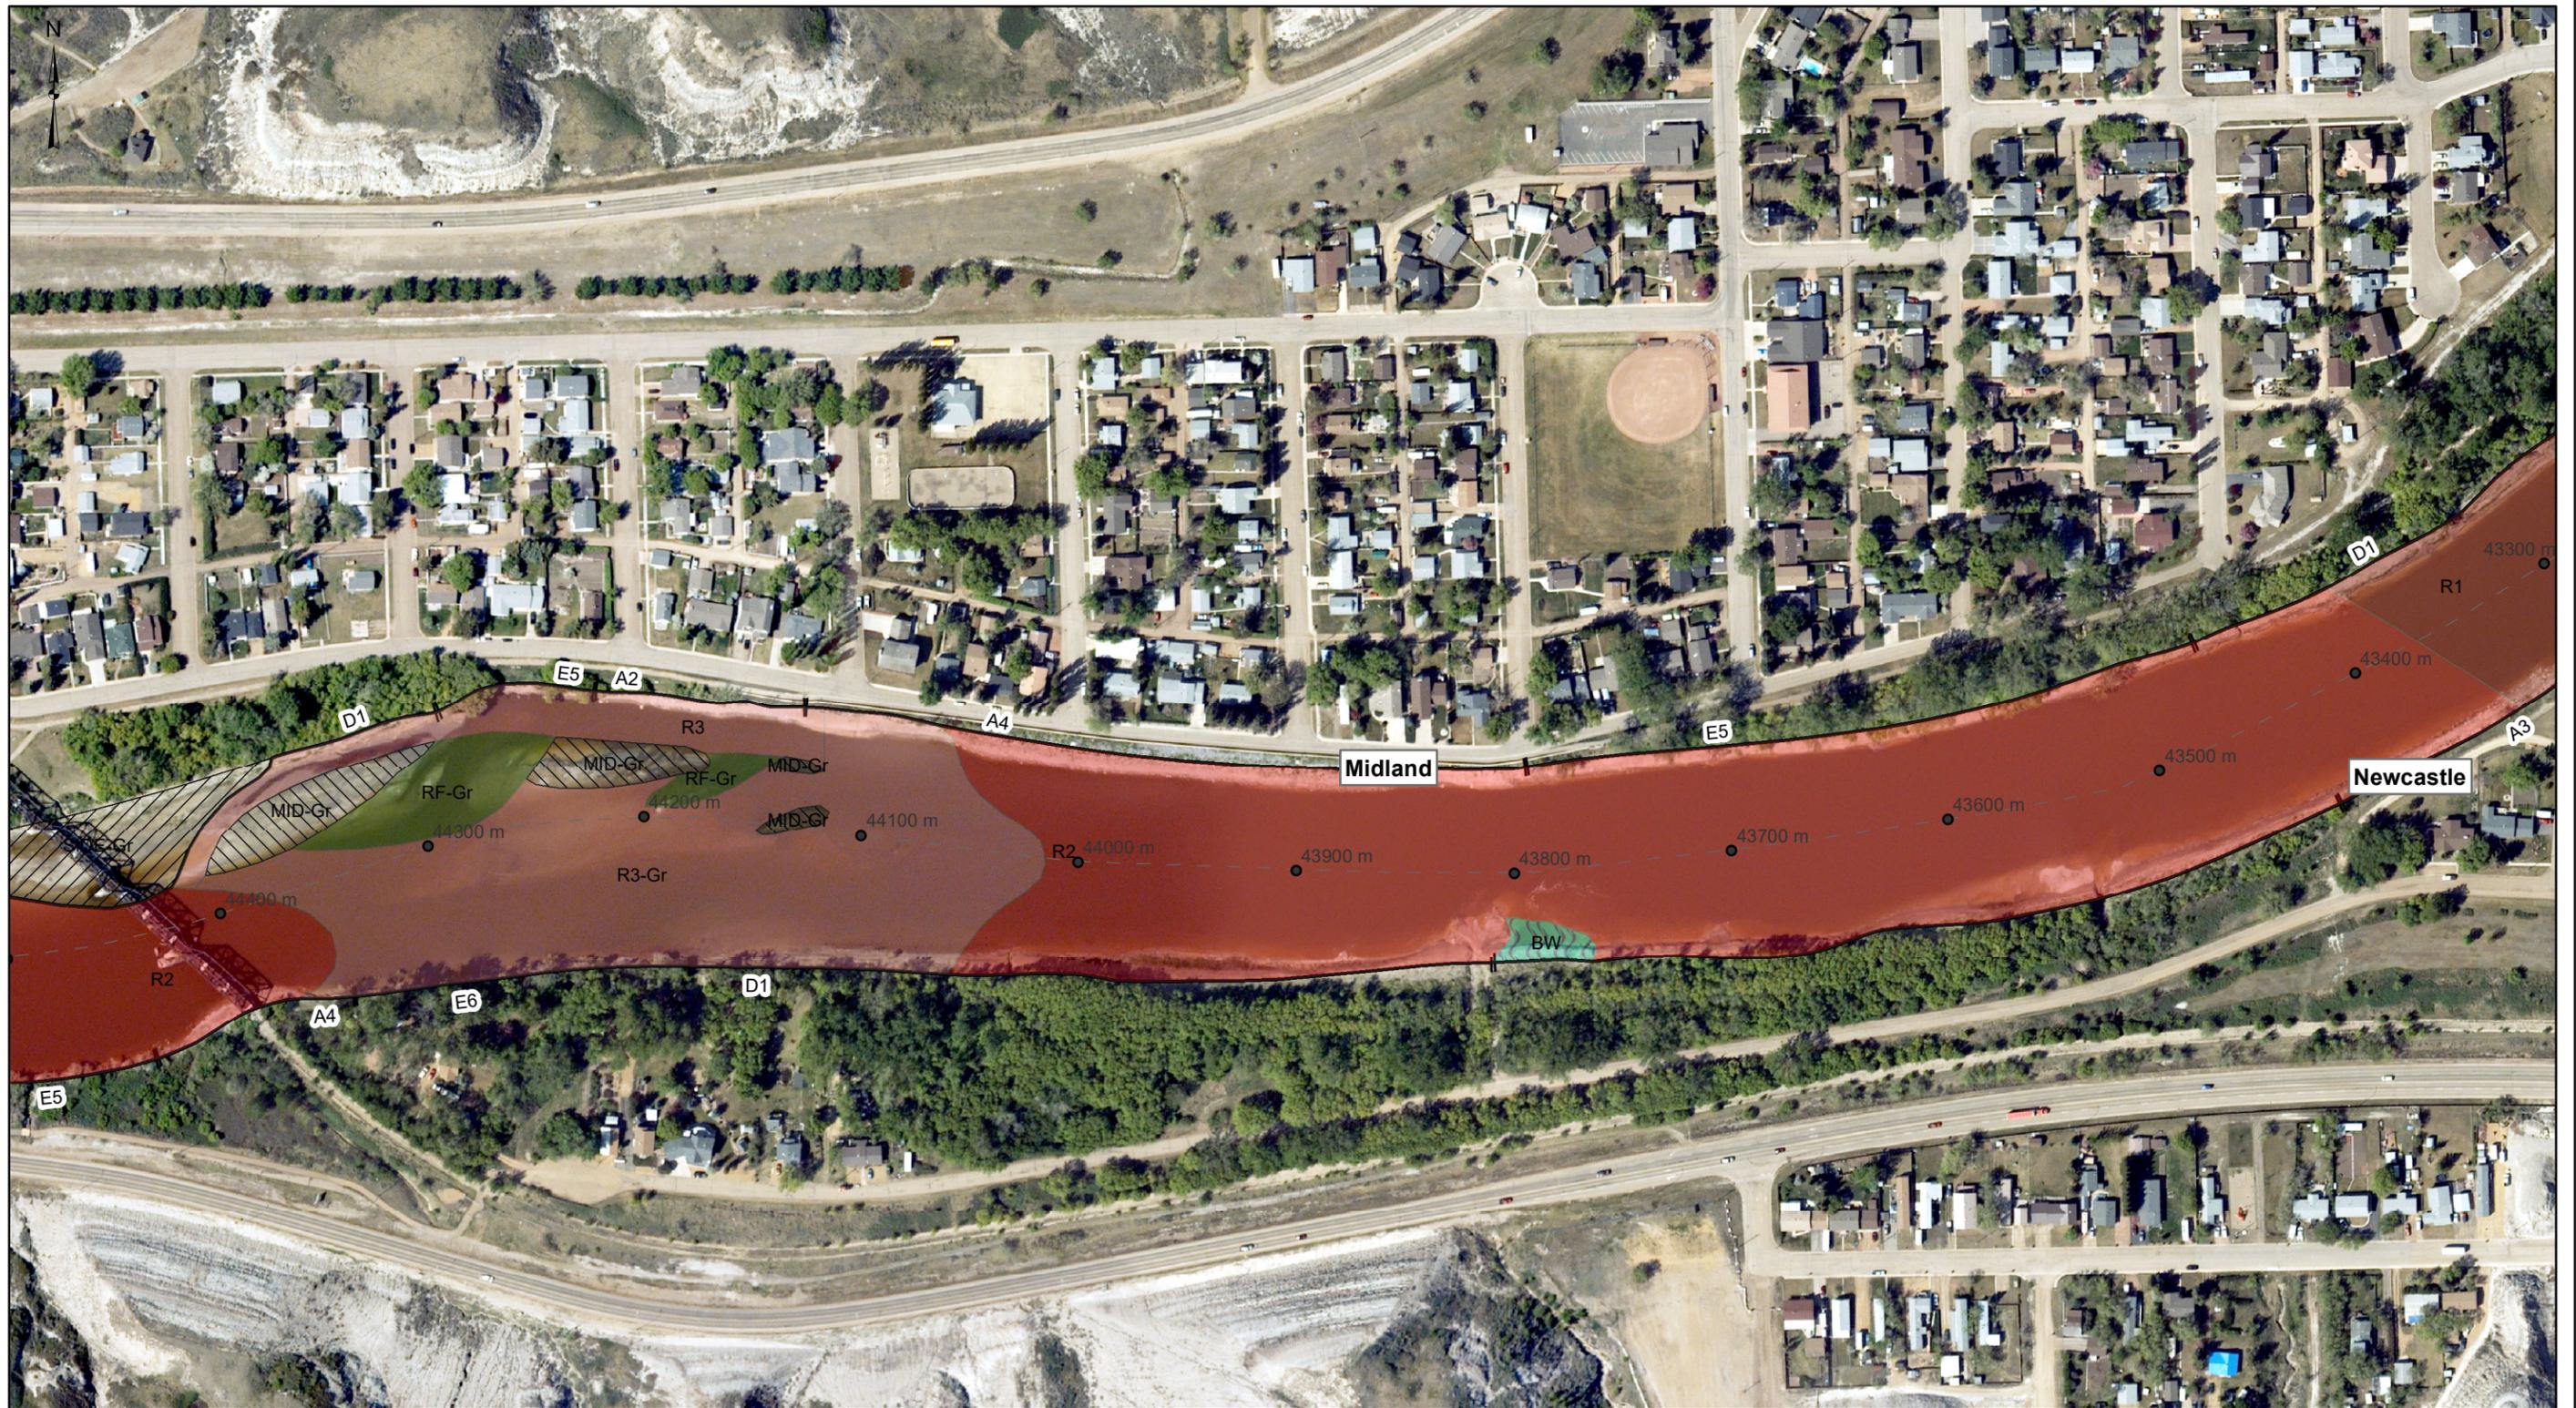
PROJECT DRUMHELLER RESILIENCY AND FLOOD MITIGATION PROGRAM FISH AND FISH HABITAT ASSESSMENT		
TITLE Fish Habitat Map - Detail (Sheet 4 of 11)		
SCALE 1:3,000	PROJECT No. A03409A01	FIG No. 5

The mainstem portion of the Midland reach upstream from the island was characterized by a combination of depositional (D1), erosional (E5), and armoured bank habitat types with little cover available (Figure 5). A shallow run occurred adjacent to the upstream portion of the Midland reach, divided from the main channel by a series of mid-channel gravel bars. Shallow riffle habitat with concentrated gravel substrate occurred between the bars and gravel also occurred in concentration within the shallow run habitat in the main channel through this area. Downstream from this area of high channel diversity, a single channel with moderate depth run habitat was present, transitioning to a deep run mid-way through the Midland reach (Figure 6).

The portion of the Study Area extending from the upstream end of the Midland reach near the old rail bridge, to the downstream extent of the Newcastle reach featured moderate to high depth run habitat (Figures 5-7). This section also included a few larger areas of riffle habitat, including the largest documented riffle near the upstream end of the island located northwest of Newcastle Beach (Appendix I: Photograph 4). The side channel associated with the island overlapped the downstream portion of the Midland reach and was characterized by snye habitat at the time of assessment (Appendix I: Photographs 5-6). Exposed coarse substrates within the side channel would potentially provide areas of shallow run and riffle habitat with seasonal variations in flow. Abundant overhanging vegetation was present along this side channel. Banks in this portion of the Study Area were frequently armoured with areas of large natural boulder armouring as well as artificial riprap.

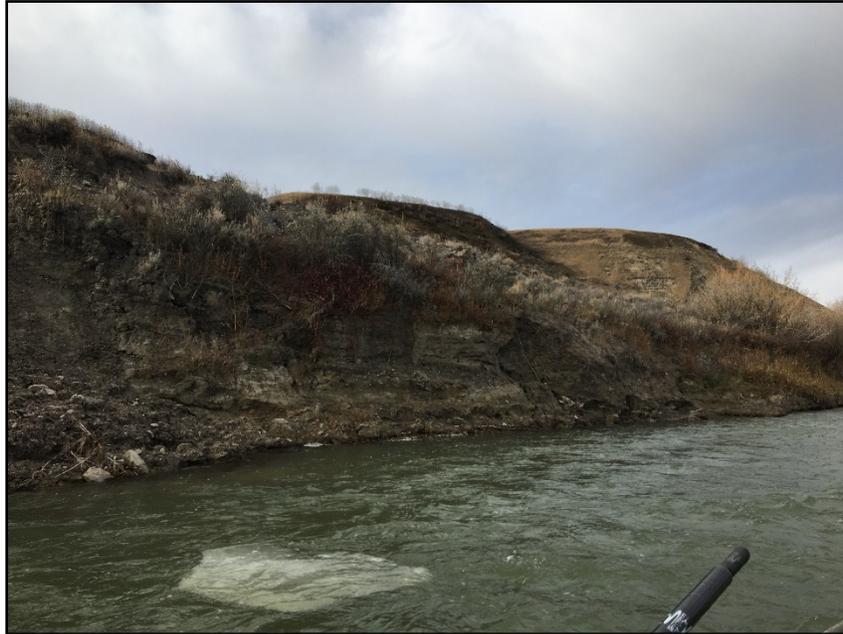
Photograph 1 Tail end of a small riffle and a high erosional (E3) bank upstream of the 55 Street flood mitigation reach.

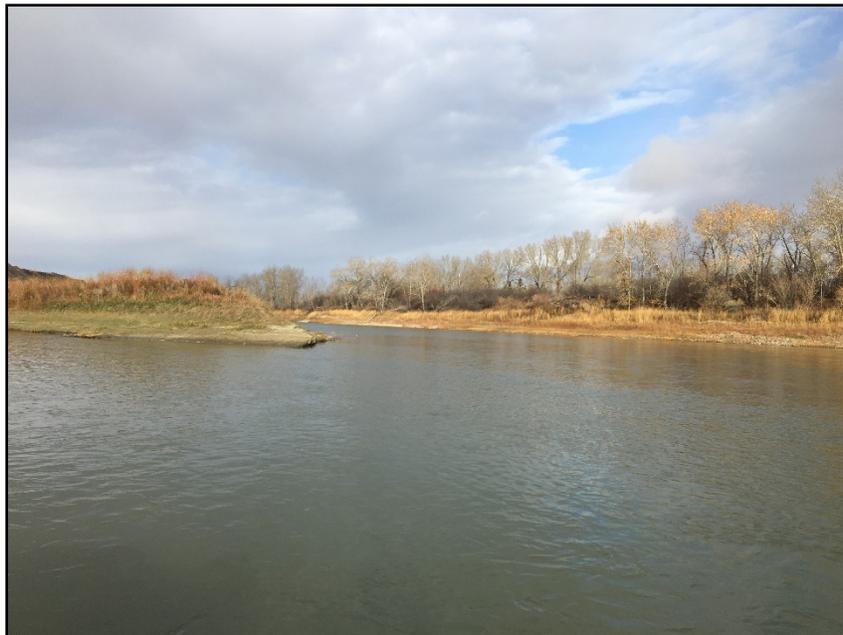
Photograph 2 Upstream view towards small island with the beginning of natural bank armour shown adjacent to the 55 Street flood mitigation reach on the left (north) bank.

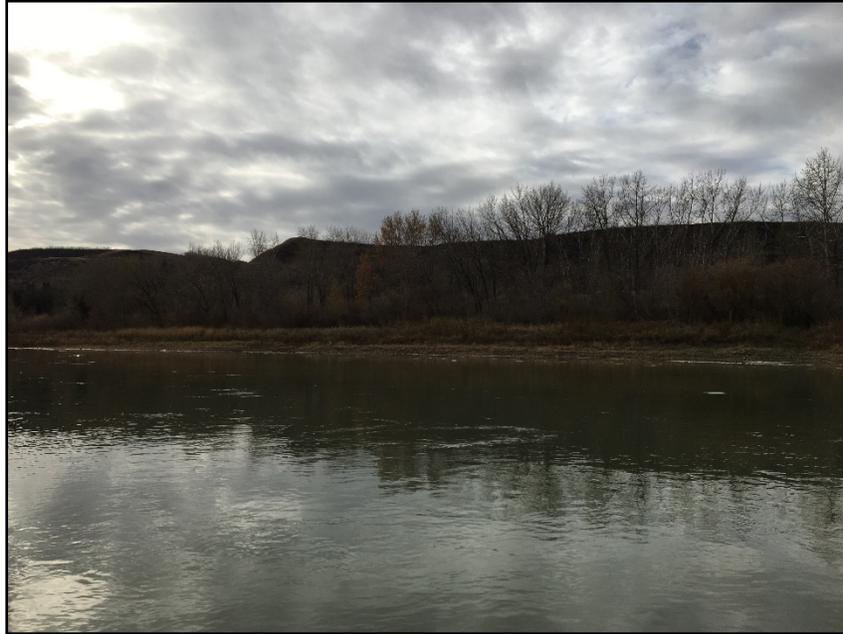
Photograph 3 Depositional bank (D2) with side gravel bar and associated backwater downstream of the 55 Street flood mitigation reach on the right (south) bank.

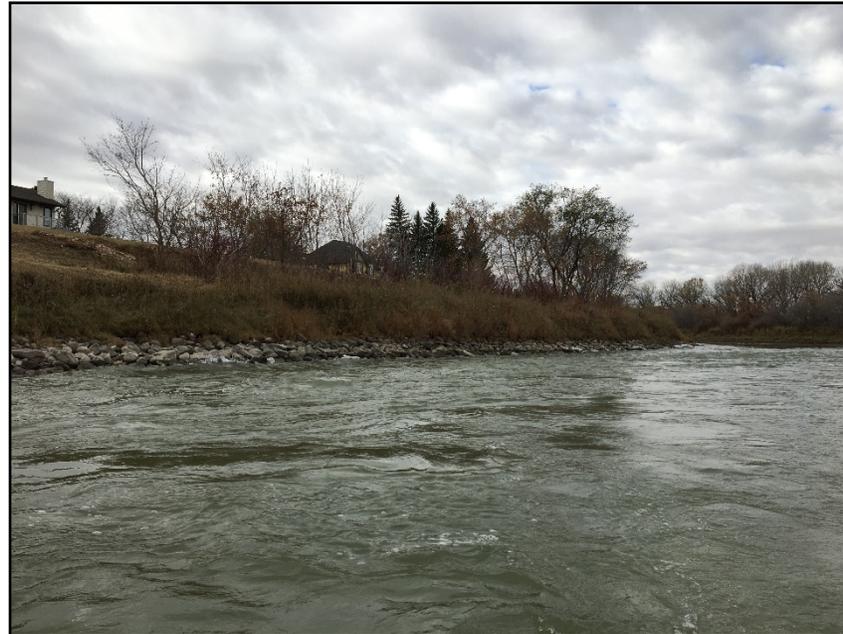
Photograph 4 Largest riffle documented within the Study Area located between the Midland and Newcastle flood mitigation reaches.

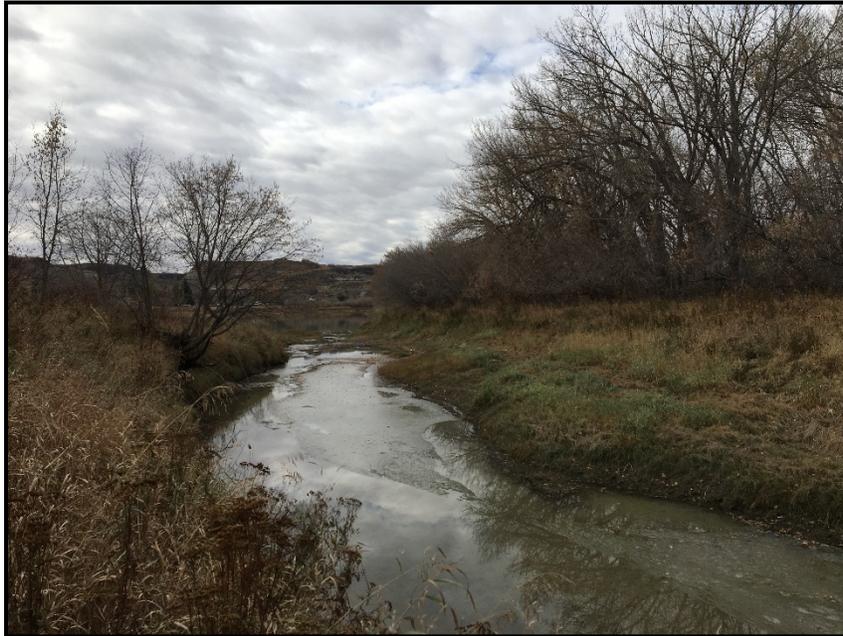
Photograph 5 Looking upstream from the upstream extent of the side channel overlapping the Midland flood mitigation reach.

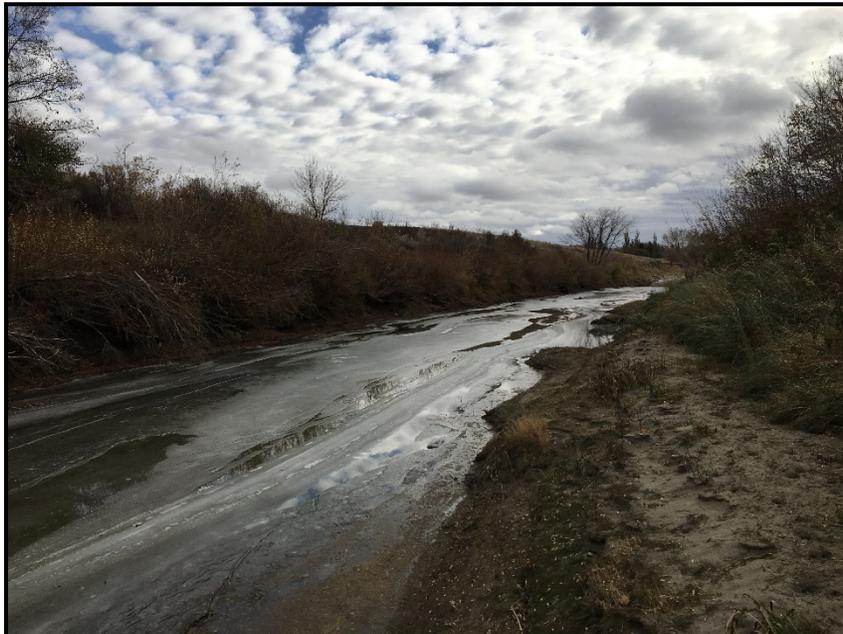
Photograph 6 Looking downstream from the downstream extent of the side channel overlapping the Midland flood mitigation reach.

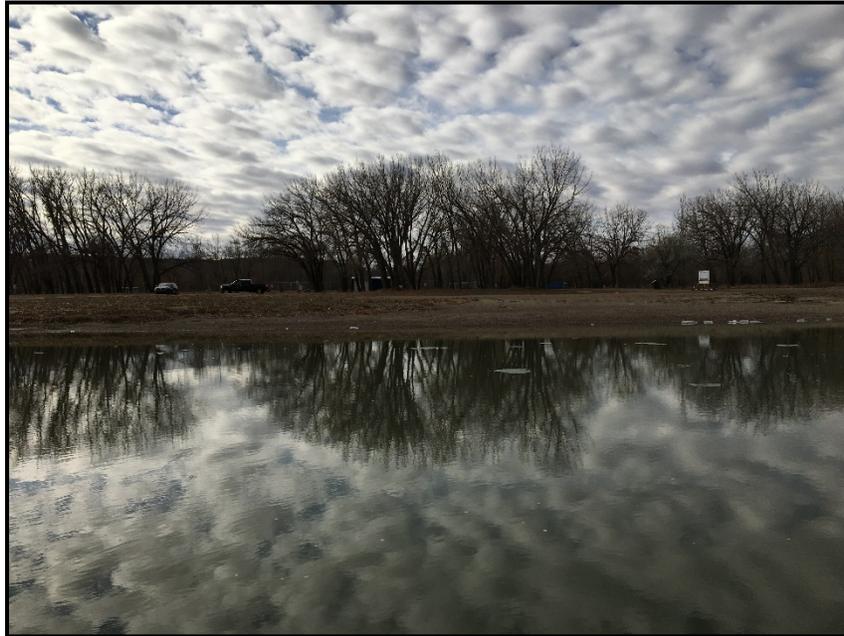
Photograph 7 Depositional bank habitat (D1-D2) consisting of a broad gravel point bar through the area of the Newcastle Beach and public boat launch.

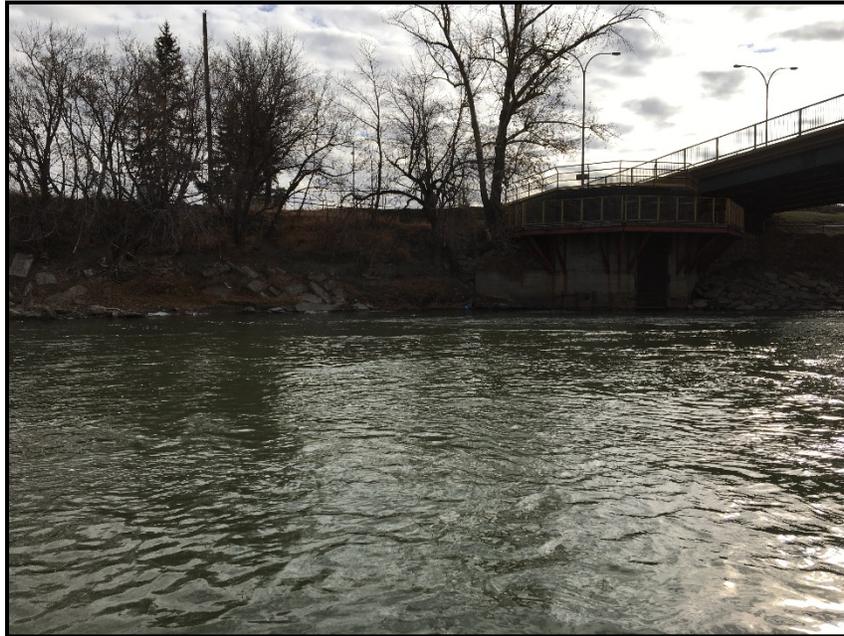
Photograph 9 Riprap armoring surrounding the abutments of the Highway 56 bridge, looking at the right (south) bank.

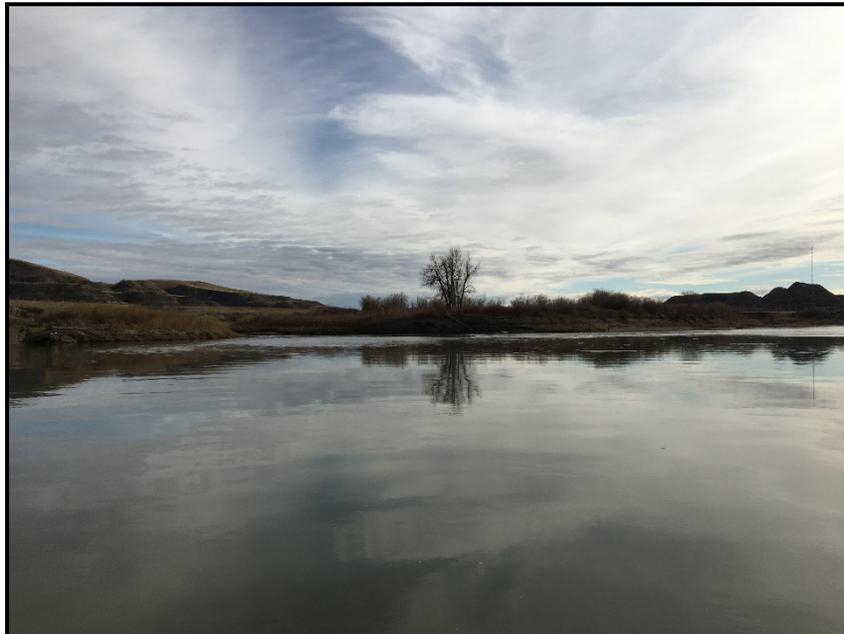
Photograph 10 Looking downstream at the large island downstream of the Willow Estates flood mitigation reach.

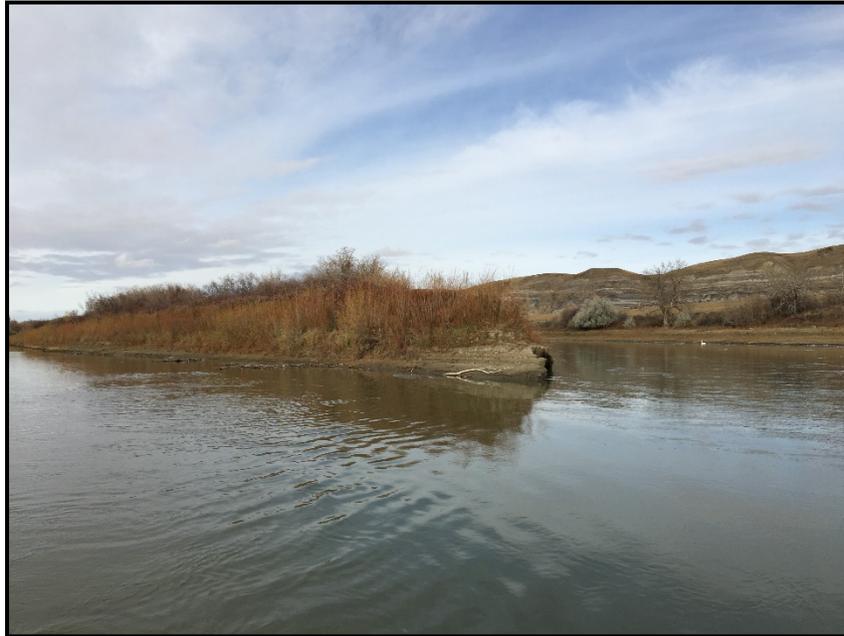
Photograph 11 Looking upstream at the large island downstream of the Willow Estates flood mitigation reach.

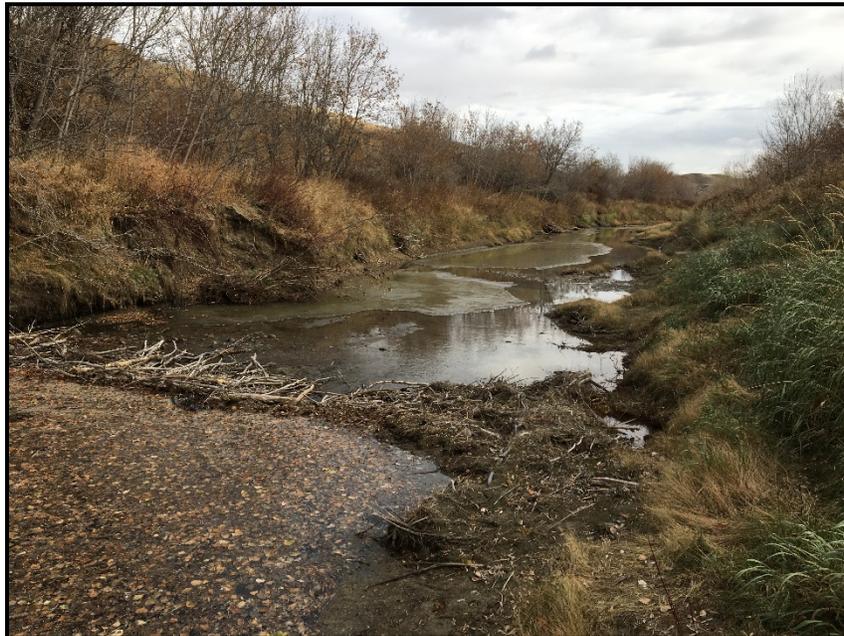
Photograph 12 Beaverdam located in the side channel overlapping the Midland flood mitigation reach.
