Town of Drumheller

Drumheller Resiliency and Flood Mitigation Program

Terrestrial Vegetation and Wildlife Assessment

A03409A02

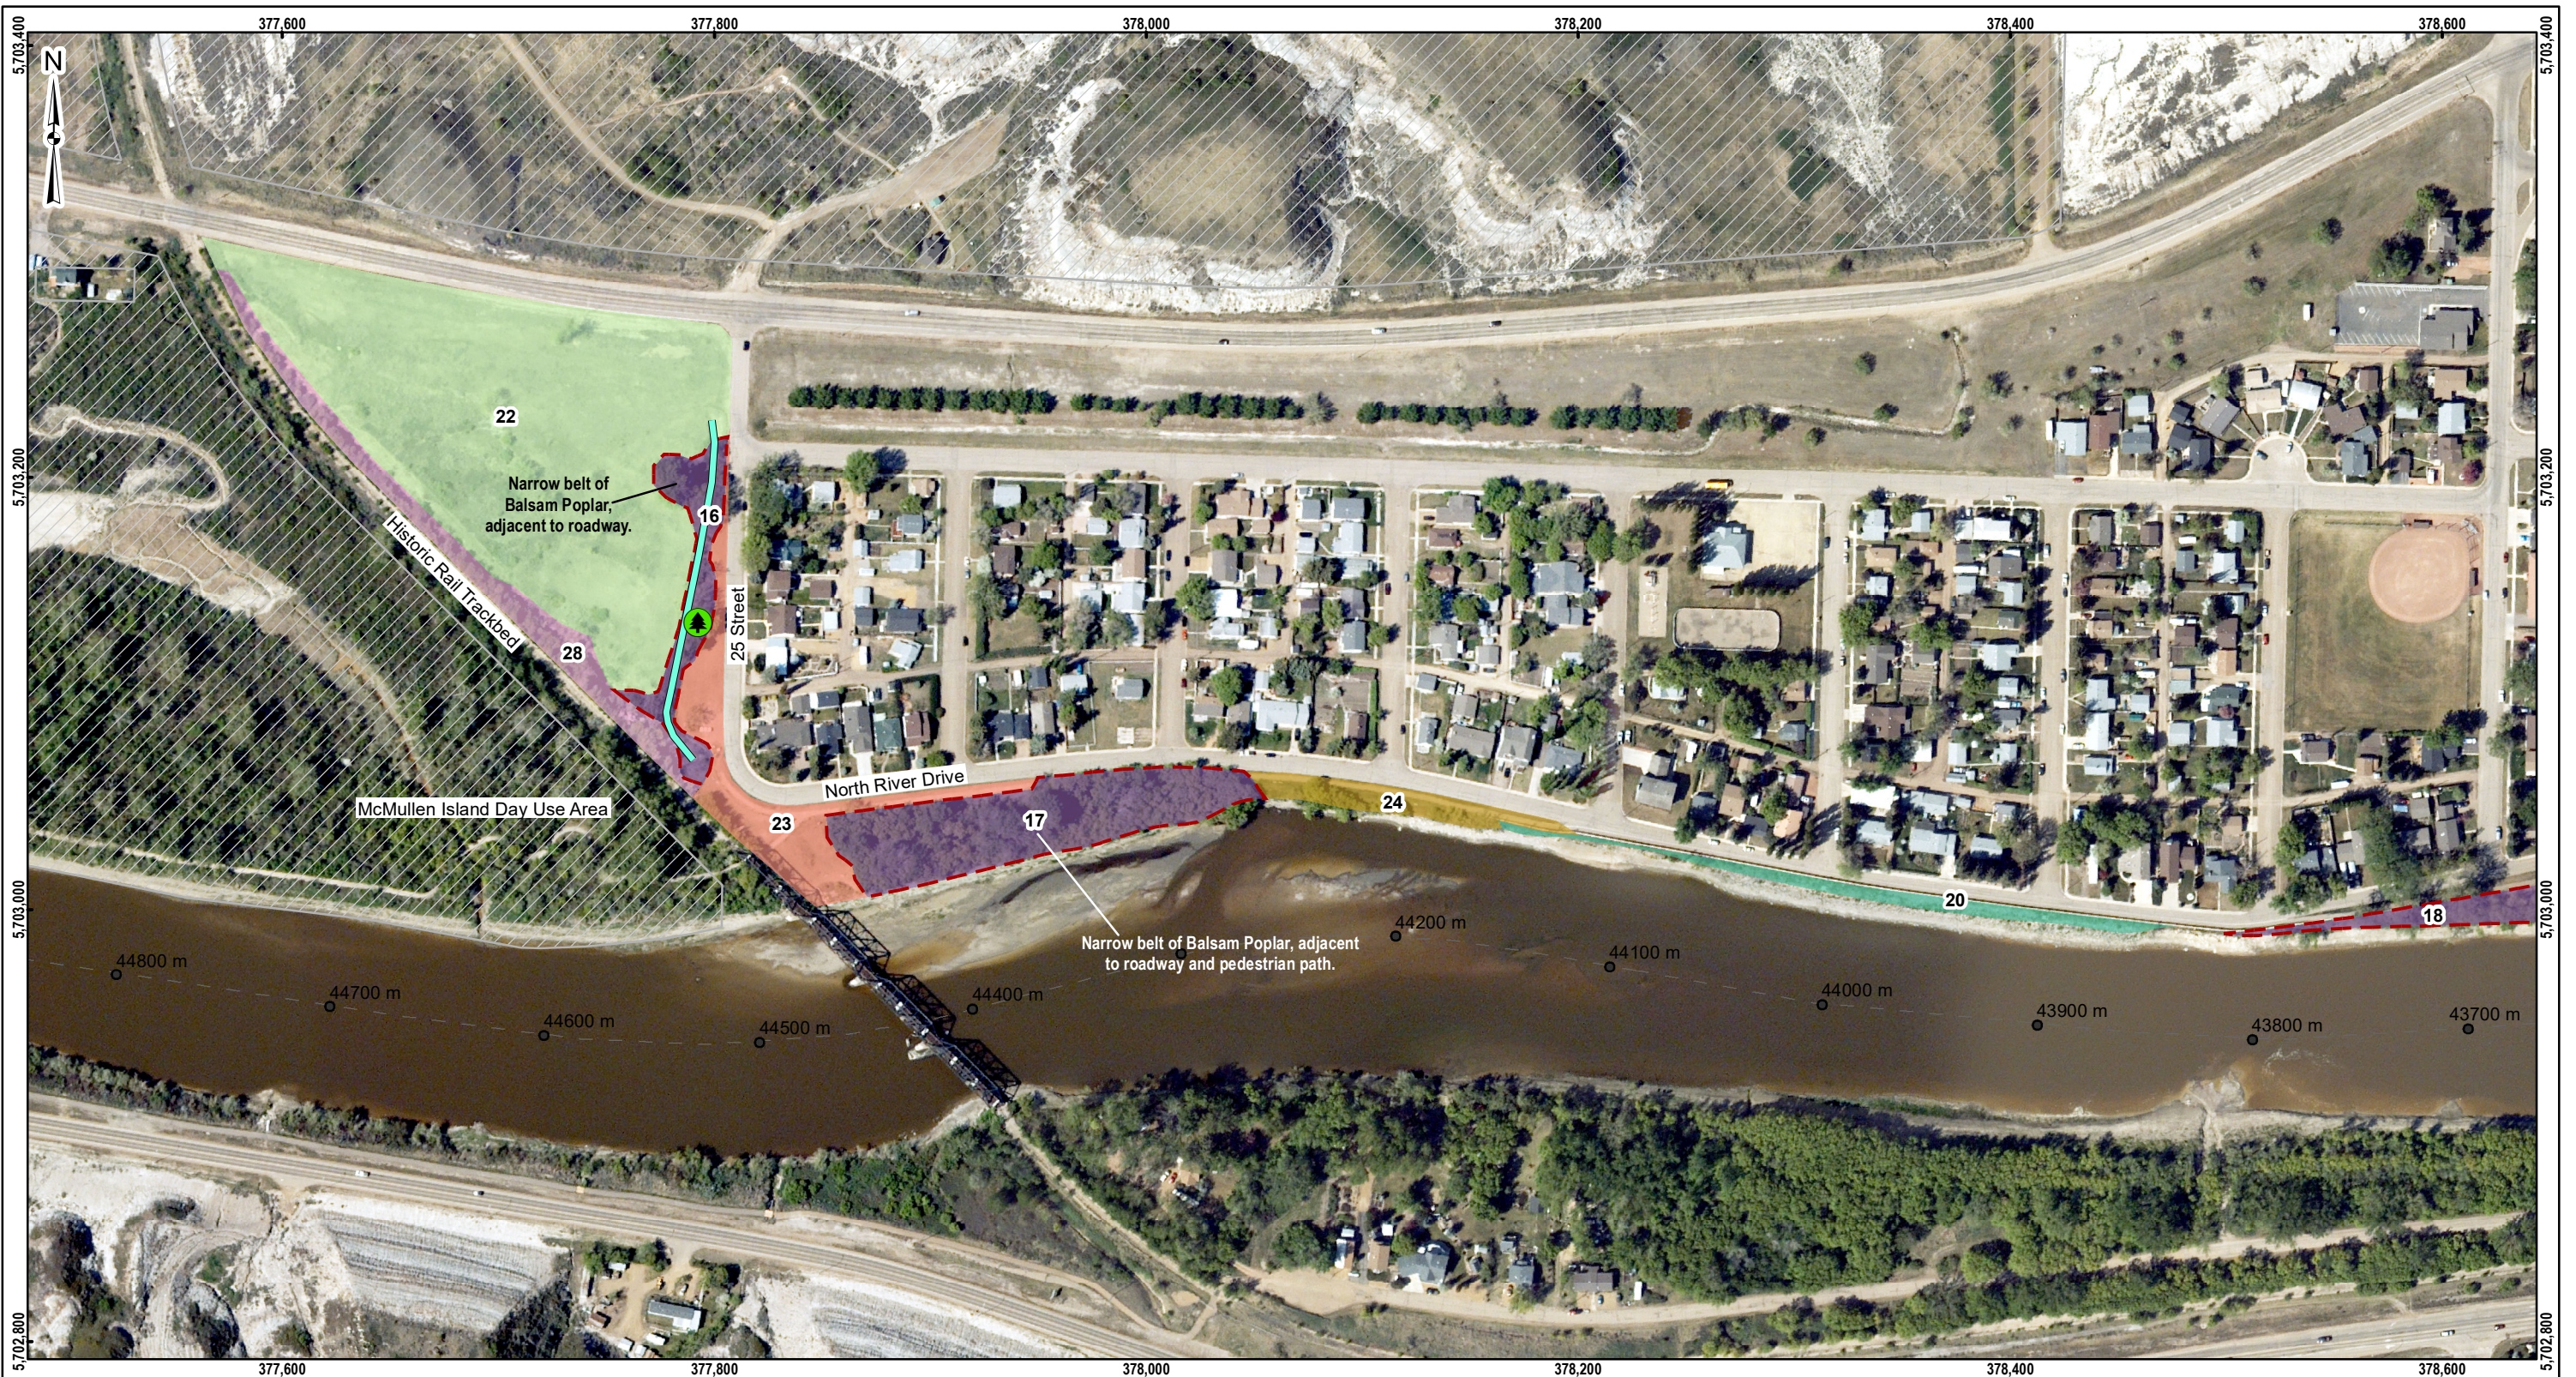
SCALE 1:3,000	PROJECT No. A03409A02	FIG No. 2-2
------------------	--------------------------	----------------

No exposed rock faces were identified as suitable habitat for disc or rock-rose lichens in the Midland reach study area. The substrate of the Bare Ground habitat (Figure 2-2: Habitat Polygon 20) is riprap and is not suitable for any rare lichens previously observed in Drumheller. The banks of the drainage ditch (Figure 2-2), the ephemeral watercourse (Figure 2-3) and any potential seepage locations along the Red Deer River also provide microhabitat opportunities for rare plants.

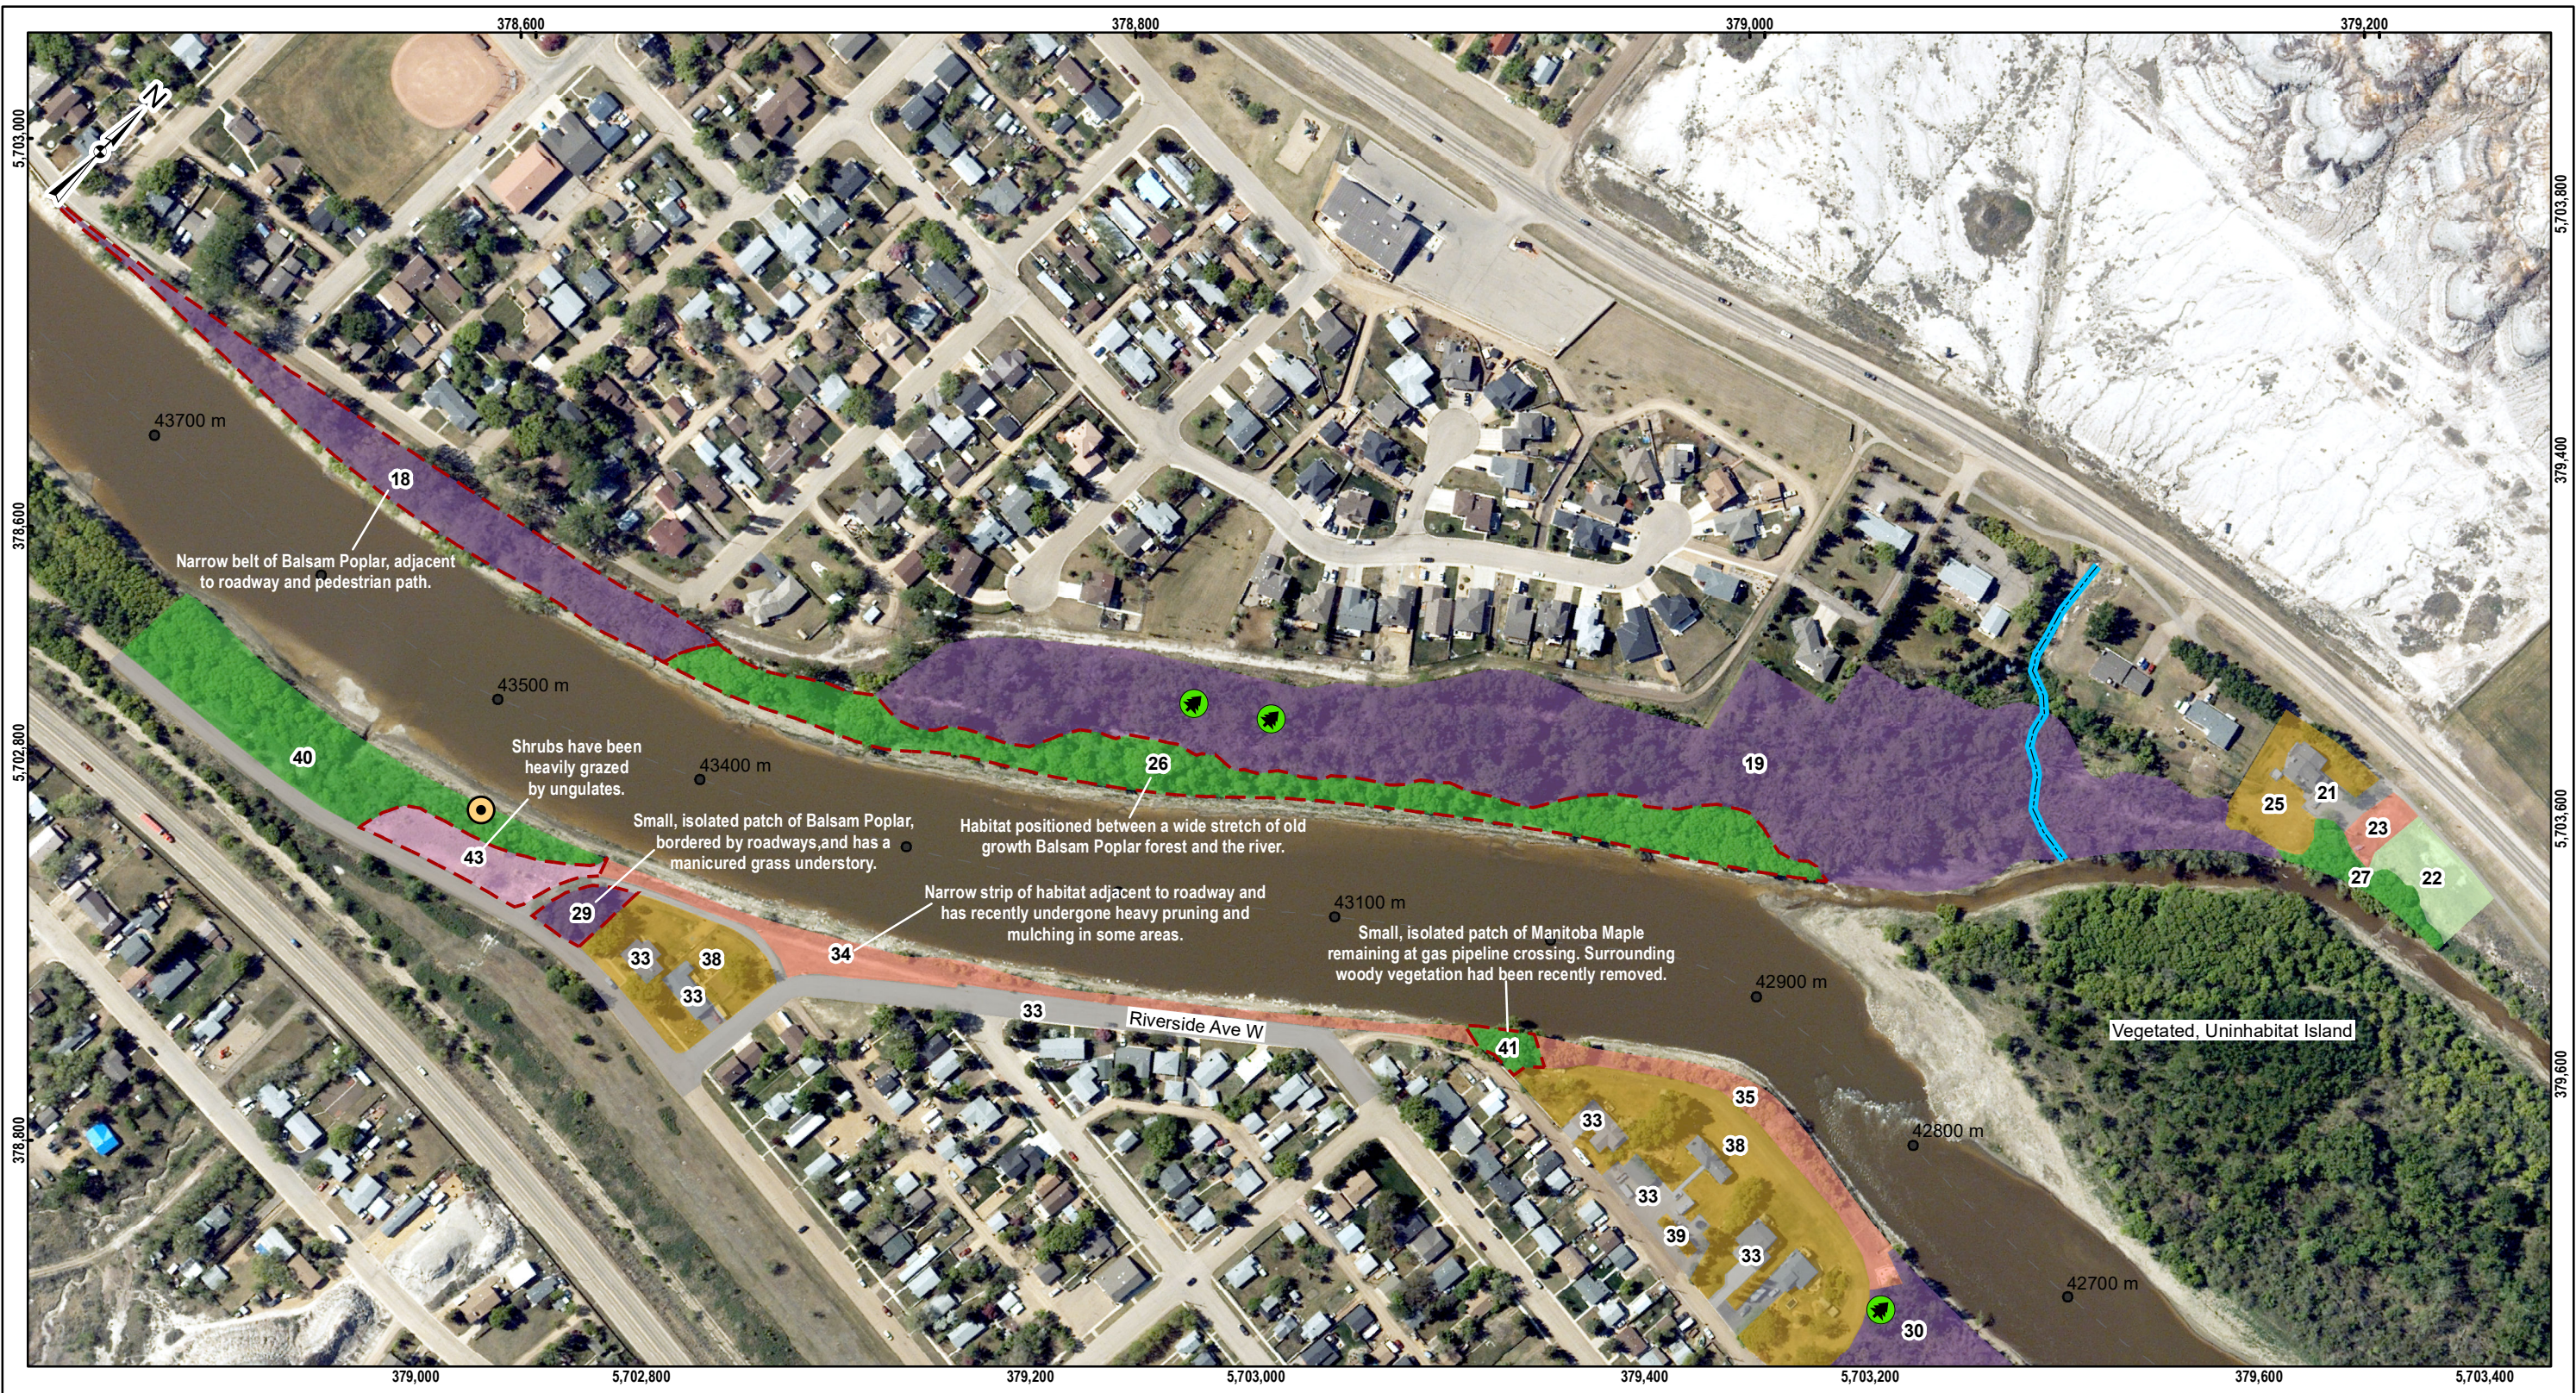
SCALE: 1:3,000 PROJECT No. A03409A02 FIG No. 2-3

Towards the east end of the Midland reach, a mature balsam poplar forest is present with a flanking Manitoba maple stand at the river’s edge (Figure 2-3: Habitat Polygons 19 and 26, respectively). The forest contains a dense shrub understory. Cavities within the mature trees were abundant throughout this stretch of riparian habitat. The mature trees were also noted to provide suitable roost habitat for bat species. Standing dead trees, referred to as snags, were also found in the balsam

riparian vegetation has been removed and replaced with manicured lawn (Figure 2-3 and 2-4: Habitat Polygon 35). Some residents have constructed patios with campfires at the top of bank.

An additional habitat feature observed during the ground survey included a rocky outcrop providing small mammal burrows on the west end of the Newcastle reach (Figure 2-3; Appendix V: Photo 12). The upland shrub habitat up the bank from the rocky outcrop primarily consisted of saskatoon bushes (*Amelanchier alnifolia*). During the ground survey, it was observed that the bushes were heavily grazed by ungulates (Figure 2-3: Habitat Polygon 43; Appendix V: Photo 13). Similar to other reaches, wildlife tracks were observed in the exposed substrate at the toe of the bank along the Newcastle reach.

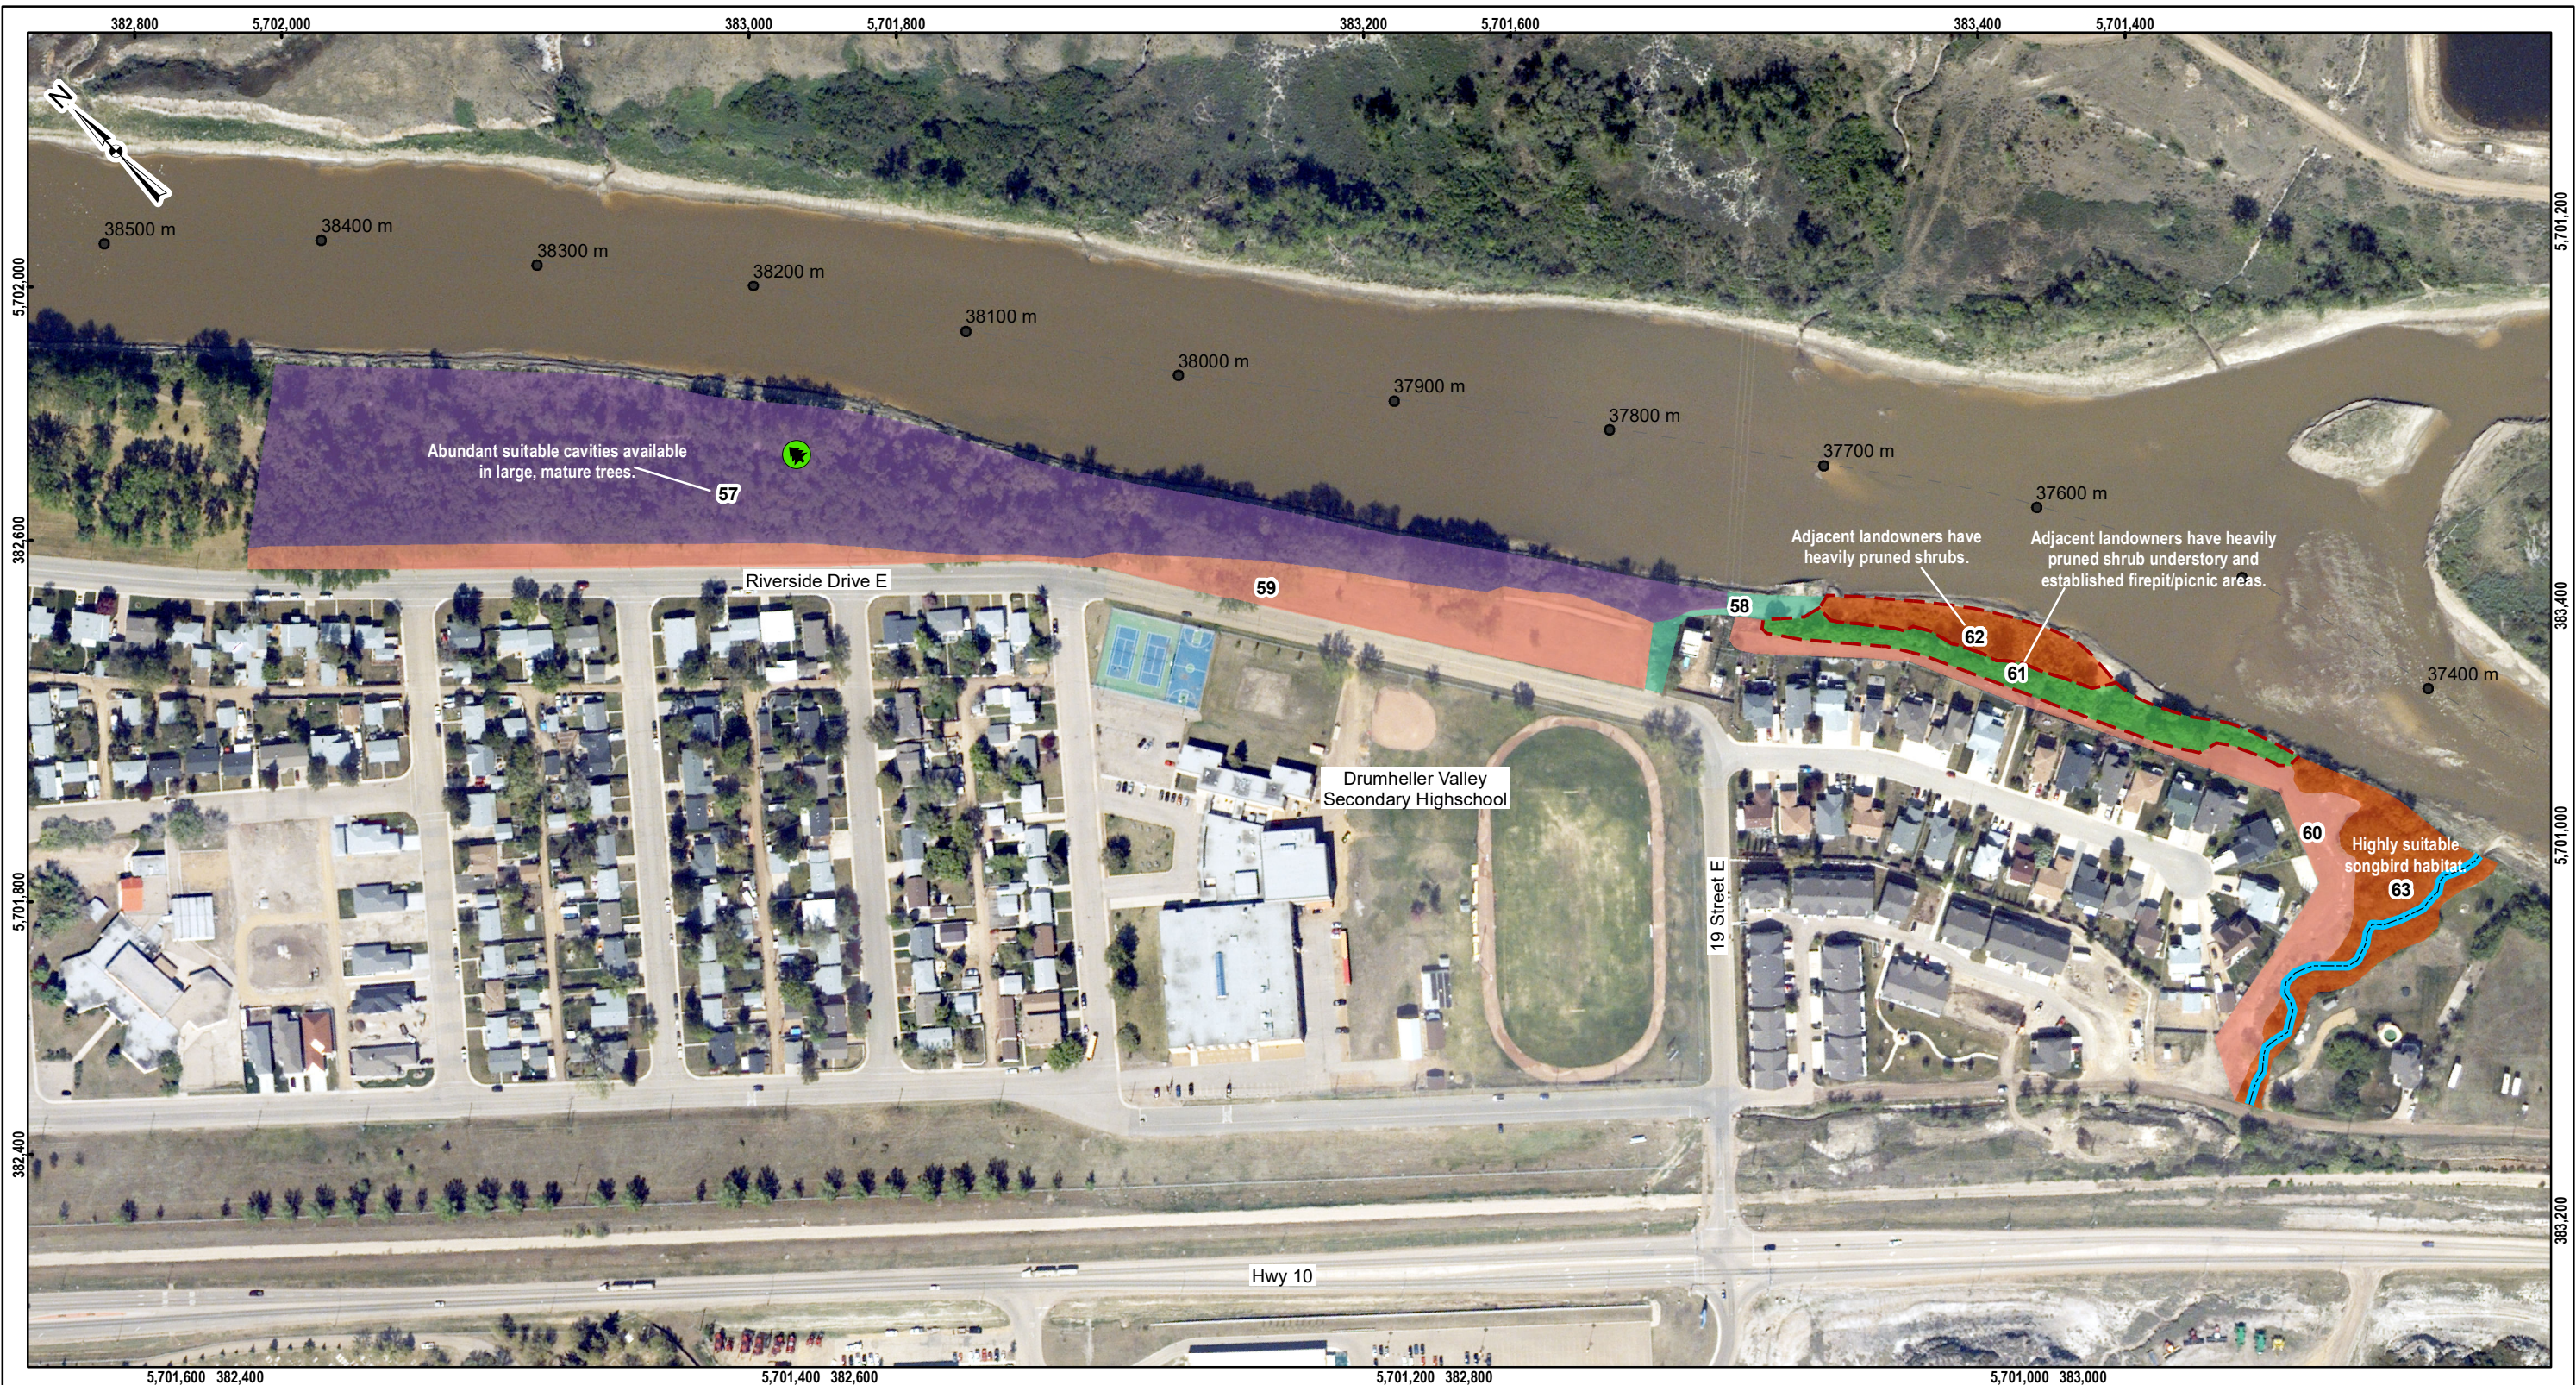
SCALE: 1:3,000 PROJECT No. A03409A02 FIG No. 2-6

The ‘riparian shrub’ habitat surrounding the ephemeral watercourse provided highly suitable habitat for breeding birds (Figure 2-6: Habitat Polygon 63; Appendix V: Photo 22). A higher density of bird nests from the most recent breeding season were observed during the ground survey.

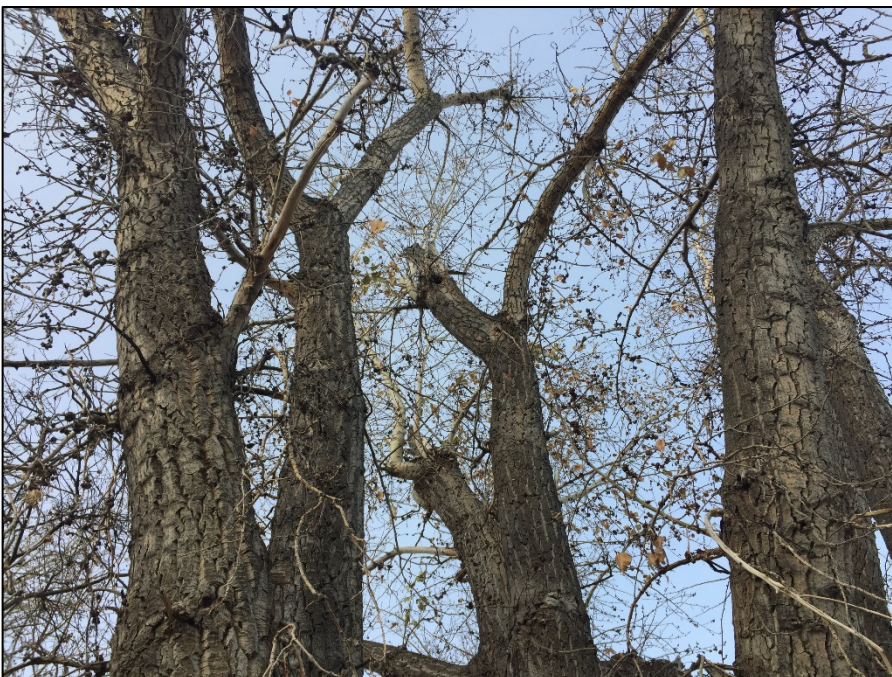
Photo 2 Cavities present within mature balsam poplars on 55th Street river terrace.

Mature balsam poplar trees are present on the river terrace (Figure 2-1: Habitat Polygon 3) and transition to riparian shrub habitat on the floodplain bench (Figure 2-1: Habitat Polygons 11-14). Wildlife habitat features observed during the ground survey through the 55th Street reach included cavities in the mature balsam poplars (Appendix V: Photo 2), dense shrub cover in the riparian shrub habitat, bird houses and feeders in the residential properties backyards, and large burrows in the vertical face of the river terrace (Appendix V: Photo 3). A thorny buffaloberry (*Shepherdia argentea*) bush was observed on the floodplain bench, providing potentially suitable habitat for a loggerhead shrike (*Lanius ludovicianus*). The mature balsam poplar trees were noted to provide suitable roost habitat for bat species.

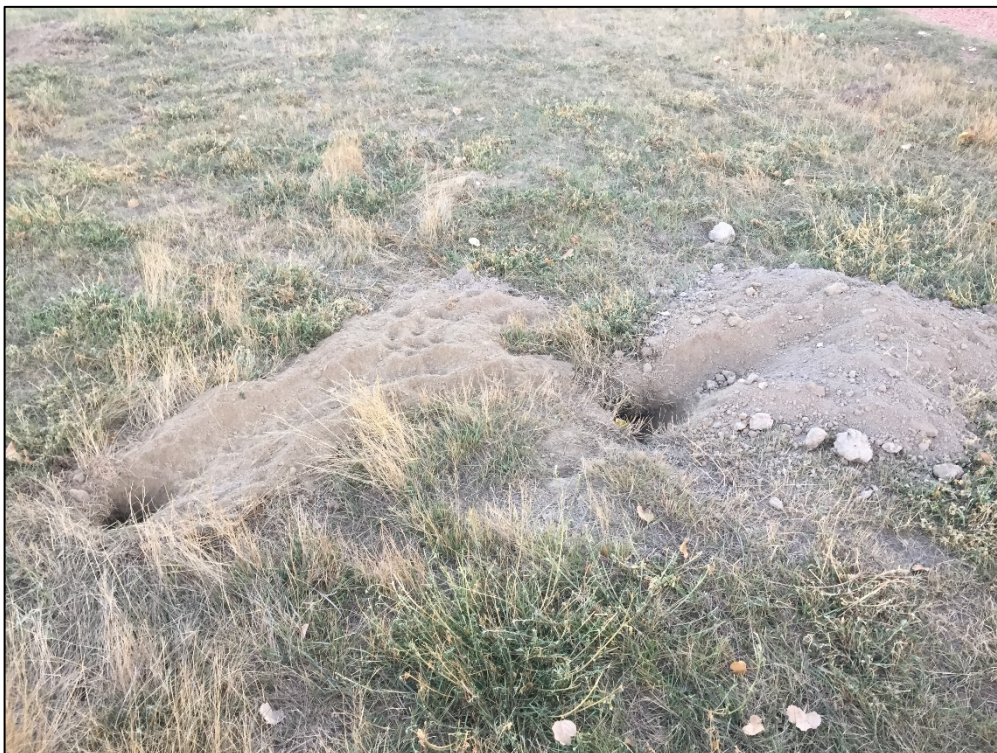
Photo 4 **American badger and Richardson's ground squirrel burrows in 55th Street reach.**

The resident of 5575 North Dinosaur Trail within the 55th Street reach indicated that his pasture (Figure 2-1: Habitat Polygon 1) has American badgers (*Taxidea taxus*) and Richardson's ground squirrels (*Urocitellus richardsonii*) (pers. comm. on Oct.28, 2020). Burrows of various sizes were observed during the ground survey (Appendix V: Photo 4) and most appeared to have recent activity.

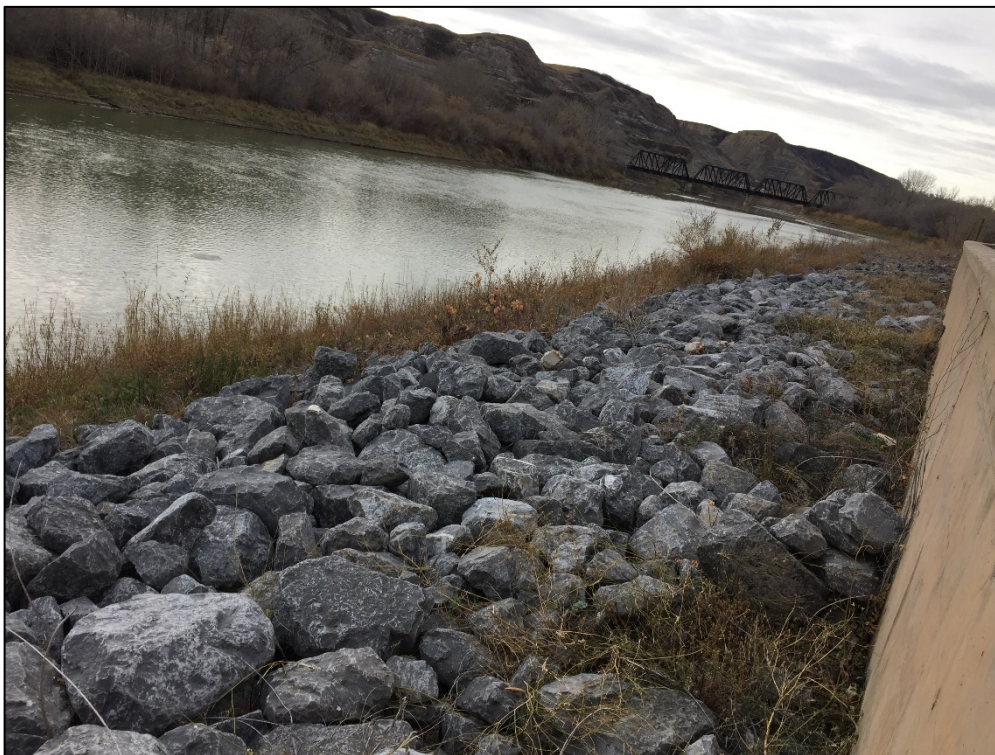
Photo 6 Armoured bank by flood control barrier present along Midland reach.

Similarly, the Midland reach provides limited suitable habitat for a snake hibernaculum. Suitable banks, fissures, sinkholes, rocky outcrops, or mammal burrows were not observed during the ground survey. Although the riprap bank is south facing along the flood mitigation barrier, proximity to residential properties and roadways and the narrow extent of the bank limited the suitability of the habitat.

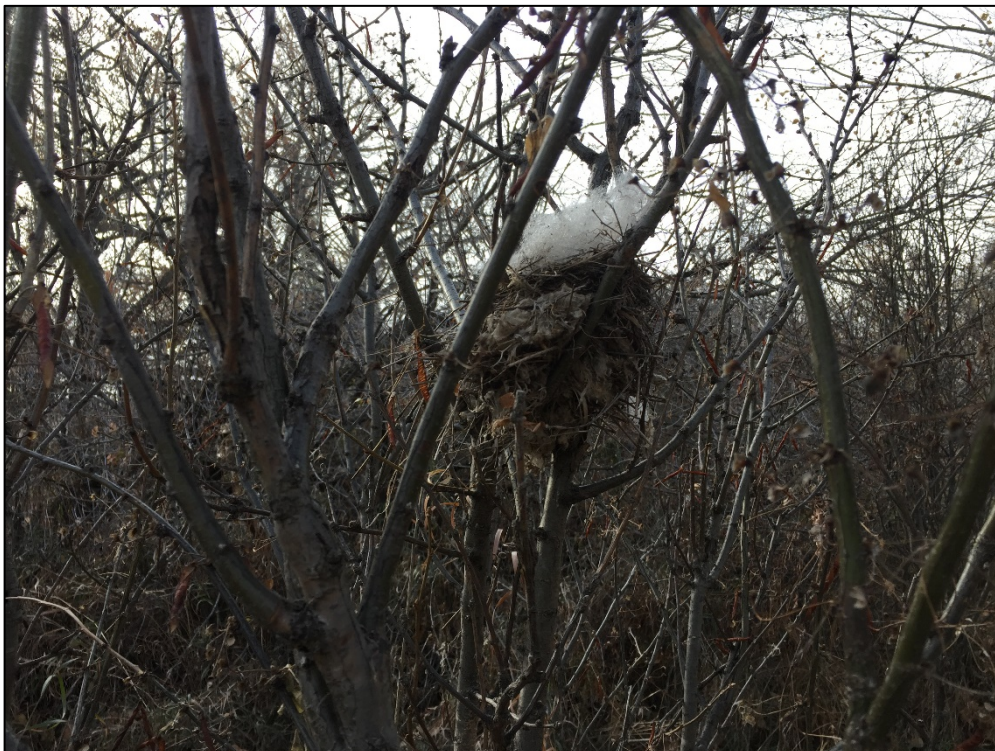
Photo 10 Bird nest present in caragana shrub in the ER of the Newcastle reach.

The ER is an open woodland dominated by mature balsam poplars (Figure 2-4: Habitat Polygon 30). Within the ER, cavities were abundant amongst the mature trees. Nests of passerine bird species (songbirds, sparrows, and finches) from the recent breeding season were observed in the shrubby understory. One nest was found within a caragana shrub (Appendix V: Photo 10). Snags were also observed within the ER (Appendix V: Photo 11).

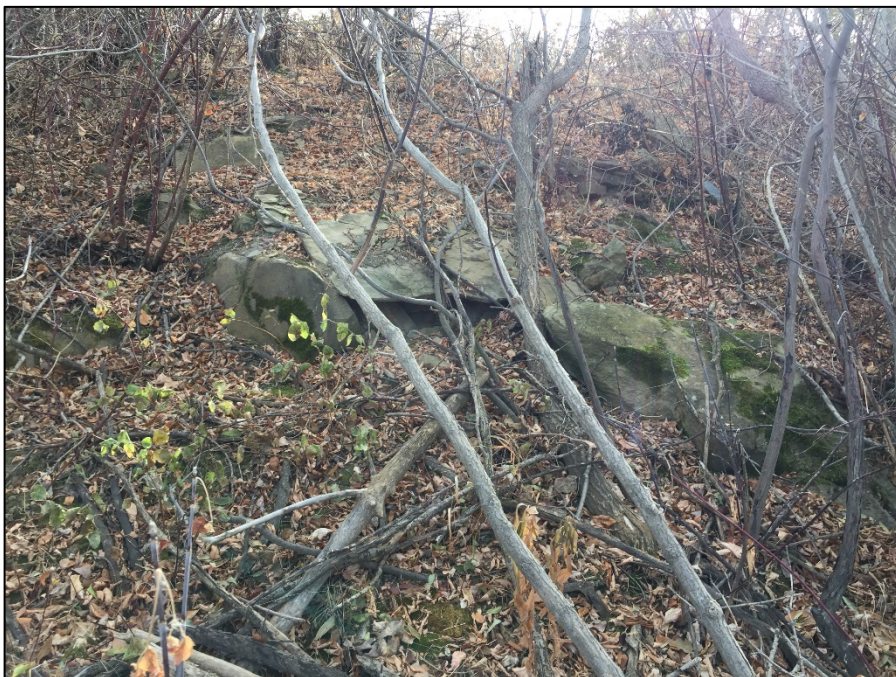
Photo 12 Rocky outcrop present at the western extent of the Newcastle reach.

No exposed rock faces were identified as suitable habitat for disc or rock-rose lichens in the Newcastle reach study area. However, a rocky outcrop supporting small mammal burrows may be suitable habitat; however, no lichens were observed during the field survey. Exposed sand at the Newcastle Beach Boat Launch (Figure 2-3) could provide the surface substrate for sand-loving Iceland lichen, but due to regular surface disturbance by people and the river, its establishment is unlikely. The ephemeral watercourse (Figure 2-3) and any potential seepage locations along the Red Deer River could also provide microhabitat opportunities for rare plants.

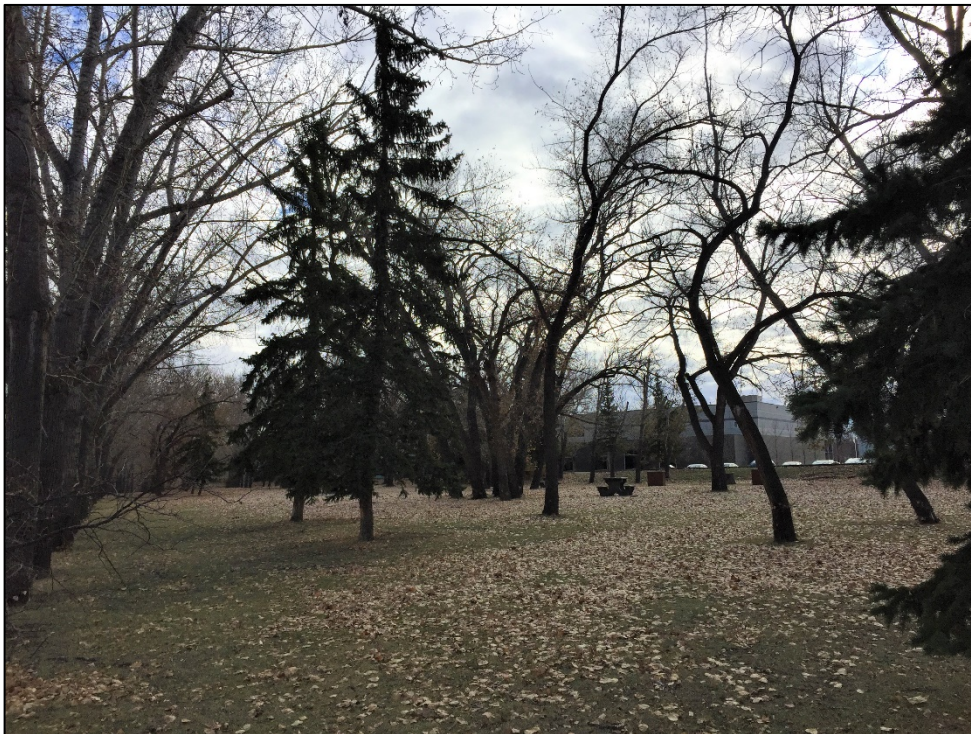
Photo 14 **Manicured park habitat throughout the Centennial reach.**

Wildlife habitat available within Centennial Park is primarily ‘manicured park’ (Table 3.5) with mature trees in the canopy and manicured lawn throughout (Appendix V: Photo 14). At the time of the ground survey, evidence of recent tree and shrub clearing was observed along the riparian zone within the park grounds. The remaining shrub habitat is sparse sandbar willow (*Salix interior*) and red-osier dogwood (*Cornus sericea*) that with a high abundance of sweet-clover (*Melilotus sp.*).

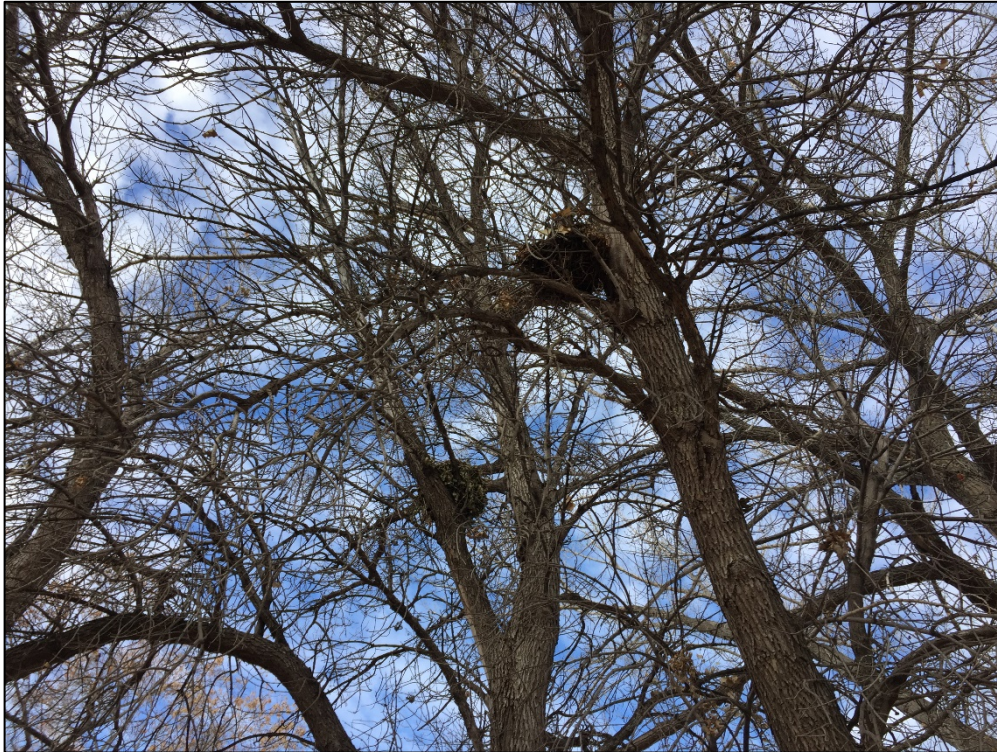
Photo 15 Cluster of American crow nests in Centennial Park.

would utilize the available habitat. A cluster of American crow (*Corvus brachyrhynchos*) nests were observed in the balsam poplar stand represented by Habitat Polygon 46 in Figure 2-5 (Appendix V: Photo 15). Beaver activity was observed throughout the riparian zone, with the base of most large trees protected by wire cylinders (Appendix V: Photo 16). Wildlife tracks were observed in the exposed substrate at the toe of the bank along the Centennial reach. The mature trees throughout the park could provide suitable roost habitat for bat species. Bird species commonly found in human habitations observed in the Centennial Park reach during the ground survey included:

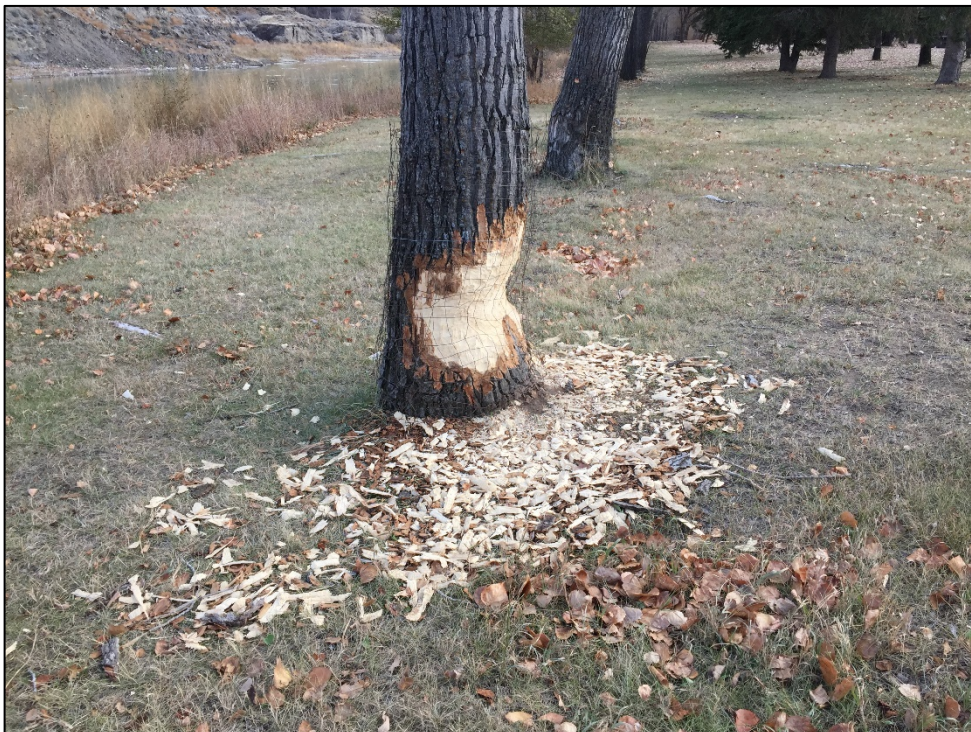
Photo 16 Beaver activity and wire cylinders around the base of mature trees in Centennial Park.

The balsam poplar forest contained mature trees with abundant available cavities. A snag was also observed within the forest (Appendix V: Photo 17). The thickness of the tree cover ranged from 20 m to 100 m, providing suitable thermal coverage for wildlife species. Suitable rooting trees were available for bat species. The bank along this stretch of the reach was as high as 2 m at some points, providing additional cover for wildlife species moving along the toe of the bank, where tracks were observed during the ground survey. Burrows were not observed in the riverbank. Large trees were observed to have wire cylinders around the base to deter beaver activity.

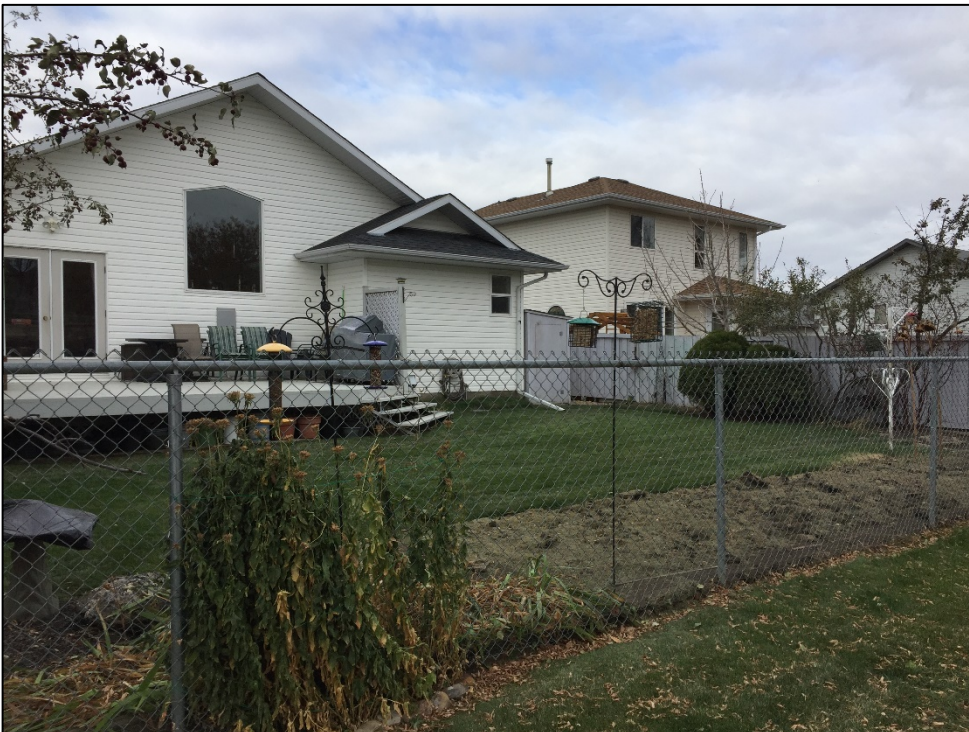
Photo 18 Bird houses and feeders present in residential backyard in the Willow Estates reach.

Along the backs of the residential yards on the eastern extent of the Willow Estates reach, numerous bird houses and feeders were observed (Appendix V: Photo 18). The manicured lawn was observed to provide forage habitat for passerine birds during the ground surveys (Appendix V: Photo 19). The surrounding shrub and Manitoba maple riparian zone has been manicured by adjacent landowners to maintain views of the river (Appendix V: Photos 20 and 21). Firepit/picnic areas have been established behind some yards. Species tolerant of human activities would utilize the available habitat but otherwise, the habitat did not provide highly suitable habitat.
