Lehigh Comprehensive Flood Mitigation Analysis Report

Drumheller Flood Mitigation
Lehigh, AB
Project # CW238408

Drumheller Resiliency & Flood Mitigation Office
224 Centre Street
Drumheller, AB T0J 0Y4

31 January 2022

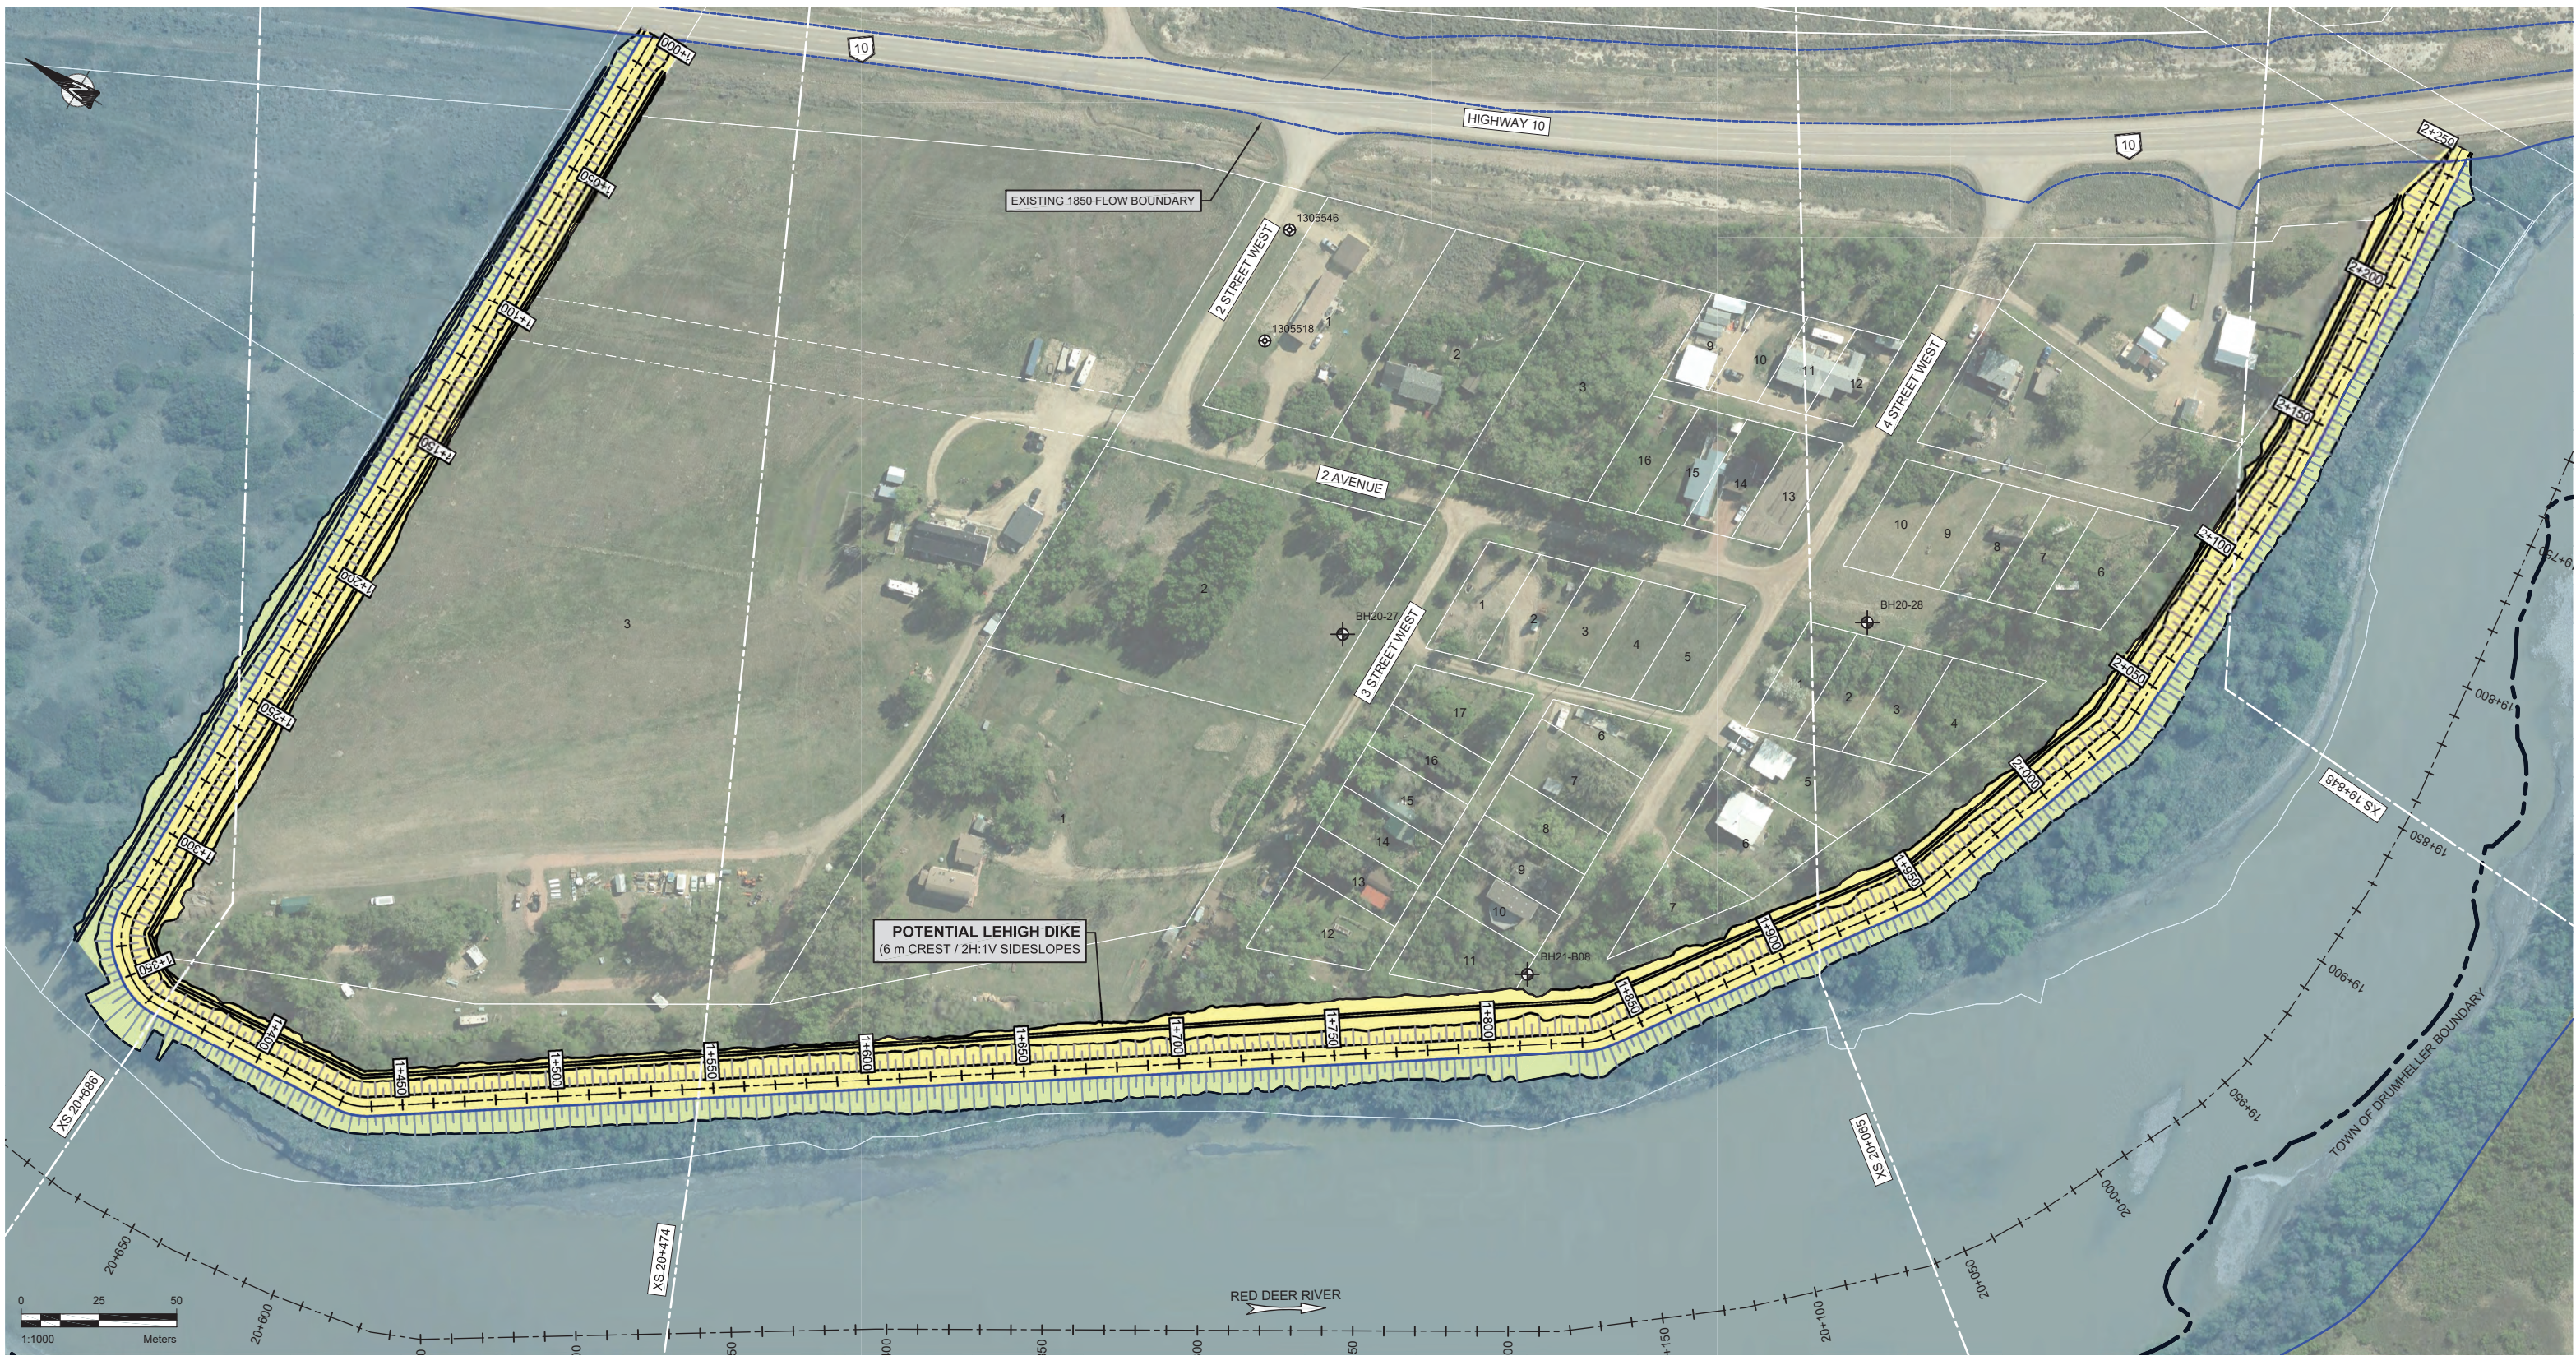
The depth of flooding adjacent to the residences, for the project design discharge of 1,850 m³/s, typically ranges from 1.1 to 1.7 m, with a median value of 1.2 m. The flood protection dike structure that is discussed in **Section 4.2** has an average height of approximately 3 m, which is higher than the depth of flooding adjacent to the residences. This is because the dike is located adjacent to the river where the ground elevation is lower and because the dike includes a freeboard of 0.75 m above the design flood level.

1. EXISTING GROUND CONTOURS INFORMATION WAS DERIVED FROM LIDAR (2018) AND PROVIDED BY DRFMO.
2. HIGH RESOLUTION AERIAL PHOTO FROM 2019 AND PROVIDED BY DRFMO.
3. FOR DIKE CROSS SECTIONS SEE APPENDIX E, FIG E.3.

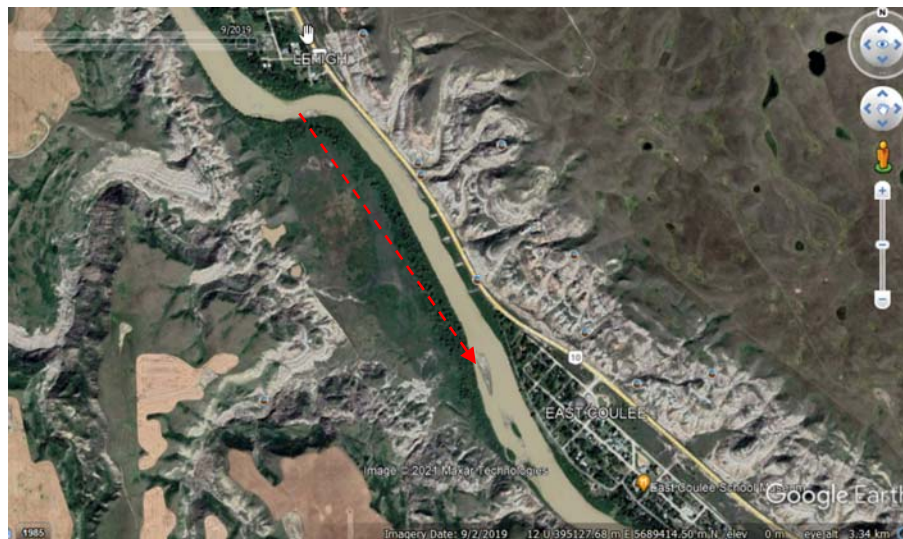
Figure 4-1: Channel Straightening Measure

- Additionally, the 'channel straightening' measure, shown in **Figure 4-1**, was evaluated. This consists of a cutoff of the meander bend that is located between Lehigh and East Coulee. This would reduce the channel length by 226 m (from 1,595 to 1,397 m). A reduction in flood depth in the order of 0.1 m could be expected based on the design flood levels. The excavation quantities would be in the order of 750,000 m³, which is an order of magnitude (i.e., ten times) greater than the channel widening/dredging measure discussed above. The costs associated with channel straightening would also be an order of magnitude greater than those noted above. Similar to the above noted channel dredging and widening measures, channel straightening is not an effective flood mitigation measure as it has minimal impact on reducing flood levels as well as having the associated environmental, economic and regulatory issues.

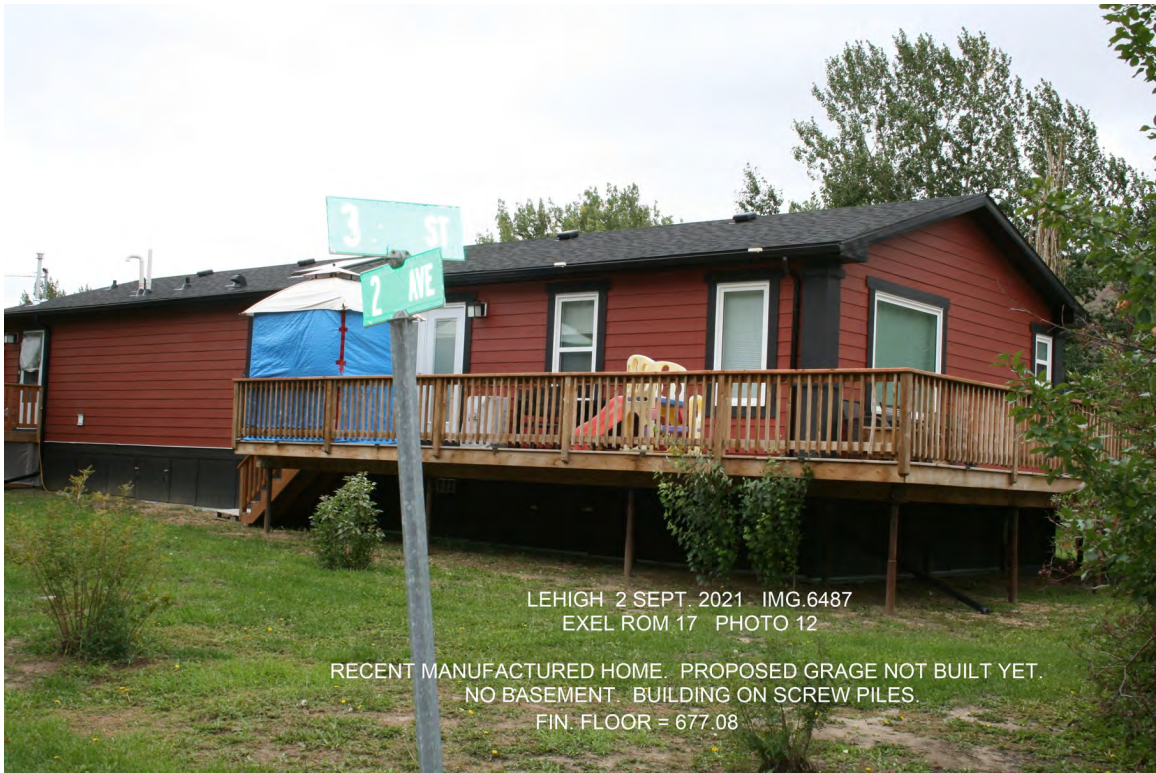
LEHIGH 2 SEPT. 2021 IMG.6487
EXEL ROW 17 PHOTO 12

RECENT MANUFACTURED HOME. PROPOSED GRAVE NOT BUILT YET.
NO BASEMENT. BUILDING ON SCREW PILES.
FIN. FLOOR = 677.08

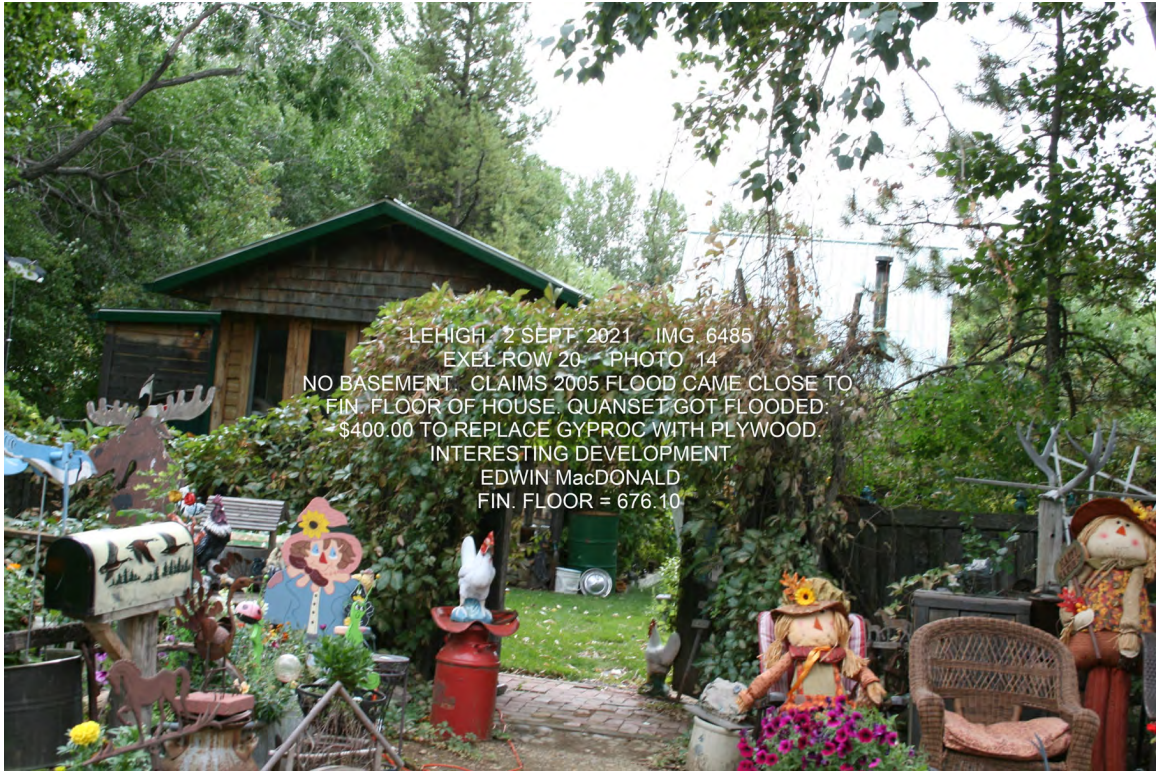
LEHIGH 2 SEPT 2021 IMG 6485
EXCEL ROW 20 PHOTO 14
NO BASEMENT. CLAIMS 2005 FLOOD CAME CLOSE TO
FIN. FLOOR OF HOUSE. QUANSET GOT FLOODED.
\$400.00 TO REPLACE GYPROC WITH PLYWOOD.
INTERESTING DEVELOPMENT
EDWIN MacDONALD
FIN. FLOOR = 676.10

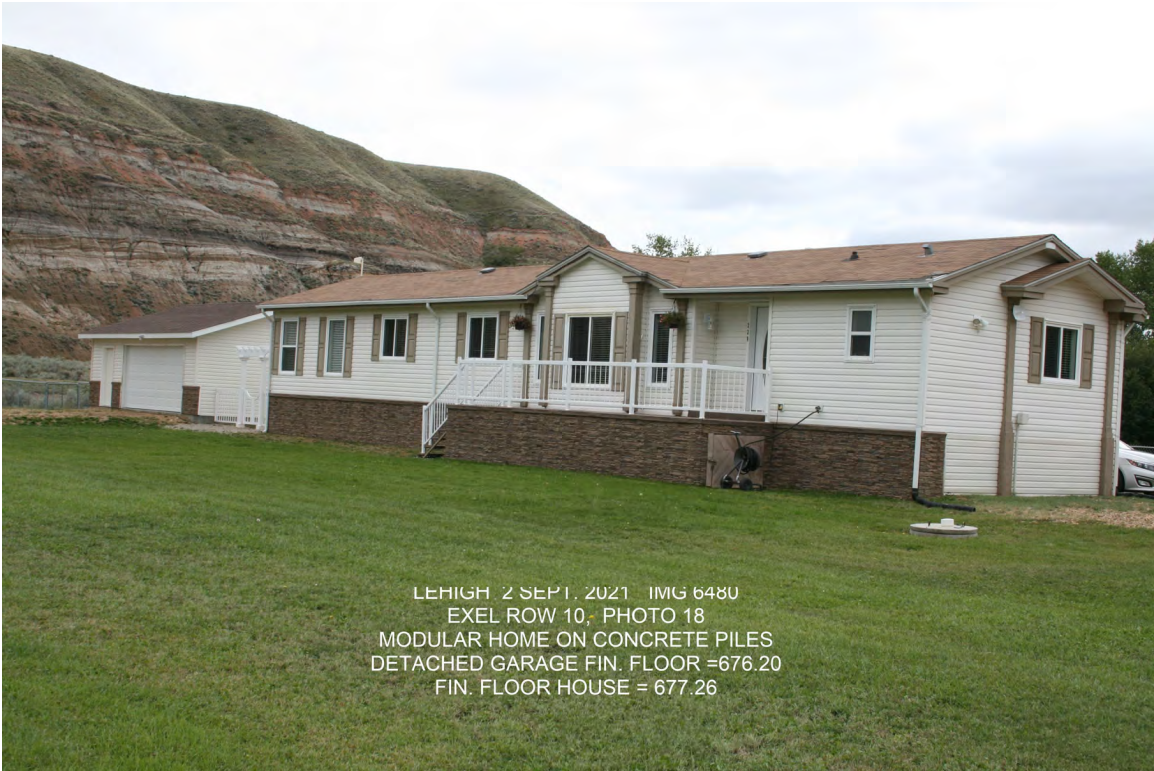
LEHIGH 2 SEPT. 2021 IMG 648U
EXEL ROW 10, PHOTO 18
MODULAR HOME ON CONCRETE PILES
DETACHED GARAGE FIN. FLOOR =676.20
FIN. FLOOR HOUSE = 677.26

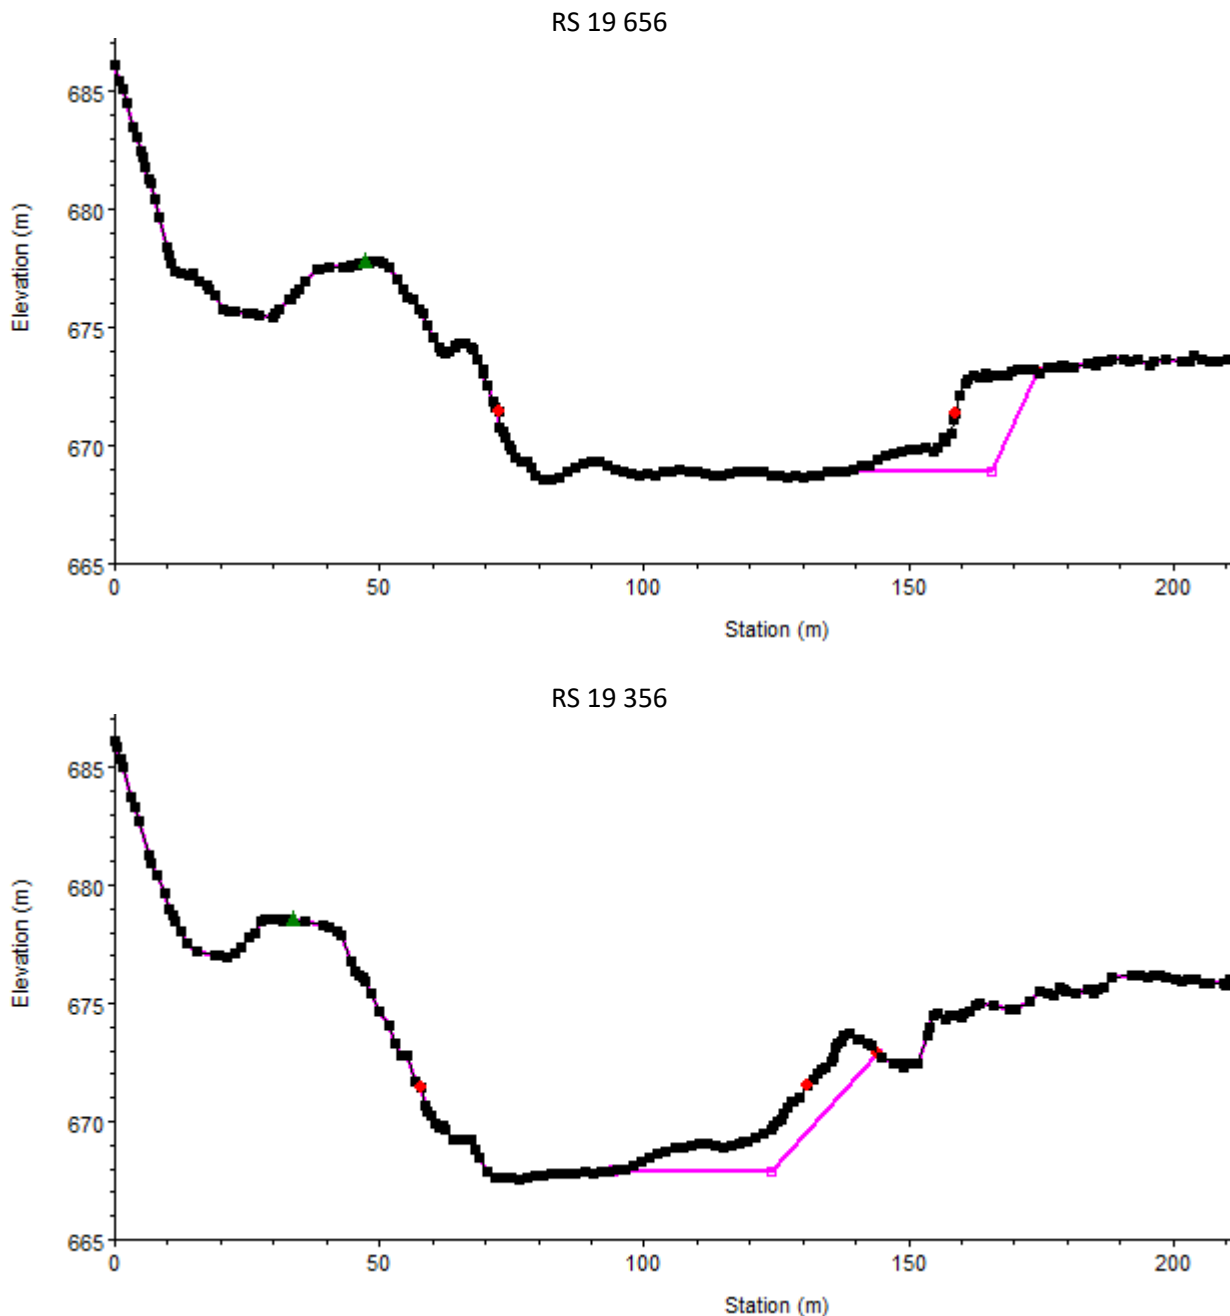
Figure 3: Scenario 1 – 10% Channel Widening over 290 m

Scenario 1 included channel widening by approximately 10% of the bankfull channel width over 290 m between RS 19 656 and RS 19 356, downstream of Lehigh. The modifications applied at each cross section can be seen in **Figure 3**. This scenario requires the removal of approximately 30,800 m³ of material.
