Town of Drumheller  
Resiliency and Flood Mitigation Office  
224 Centre Street  
Drumheller, Alberta  
T0J 0Y4

## **Midland Flood Mitigation Barrier - Pre-Disturbance Wildlife Sweep**

Project Number:  
Date: JULY 2022  
DRUMHELLER RESILIENCY AND FLOOD MITIGATION PROGRAM  
MIDLAND FLOOD DIKE UPGRADES

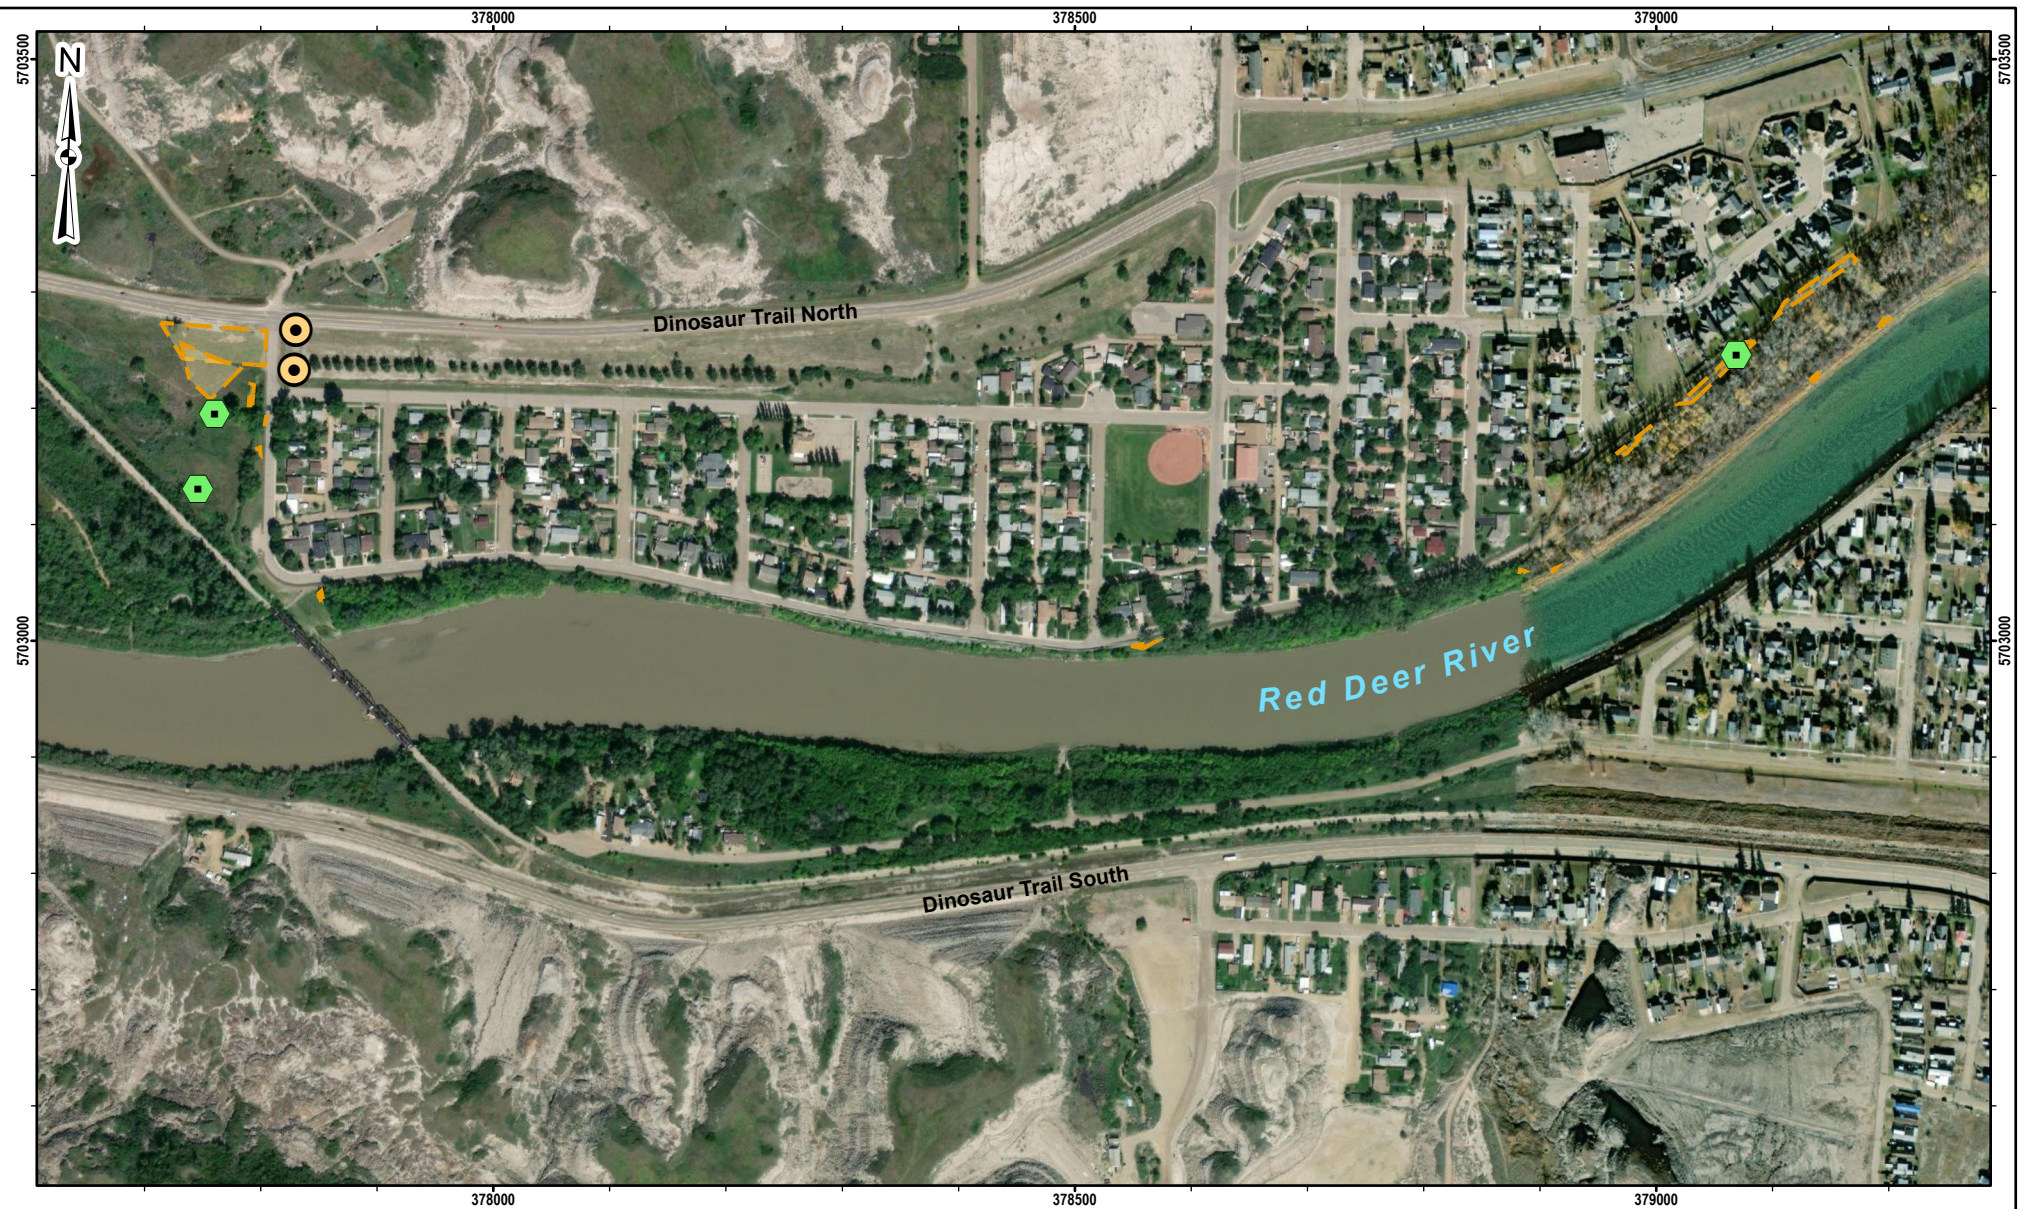
SENSITIVE WILDLIFE & VEGETATION

The area swept was clear of occupied nests on August 31, 2022. Two small mammal burrows were identified but did not appear to be established recently, nor did they appear active. It should also be noted that the area appears to be a recreational area frequented by children, with constructed forts and areas with lawn chairs.

Multiple areas over the entire extent of the Project area had deer feces present, as well as bedding areas among the grassy areas adjacent to the tree lines (Figure 2). Two juvenile mule deer (*Odocoileus hemionus*) were observed running along the tree line. A third mule deer was spotted in the forested area adjacent to the Project area, and whether it was one of the juveniles observed earlier is unknown.

As requested, Figure 2 maps locations within the Project footprint with sage that may be suitable for harvest by the Calgary Zoo.

The peak of breeding activity for most birds occurs between late May and July, though early nesting species, such as owls can nest as early as mid-February. With construction occurring outside this window, it is unlikely new nests would become active, and therefore the risk is considered negligible. Deer in the area would more likely shelter in the treed areas adjacent to the Project site. Peak fawning season for mule deer occurs in early summer and has since passed. The observed juvenile deer were mature enough to leave an area of disturbance on their own. Caution should be taken when developing grassy areas suitable for bedding that no young are present. When clearing vegetation, all vegetation should be removed so that regrowth in the cleared area is minimized.
