# The History of Drumheller Valley

# Drumheller Valley History of Flooding

### Drumheller's Flood Resiliency Program

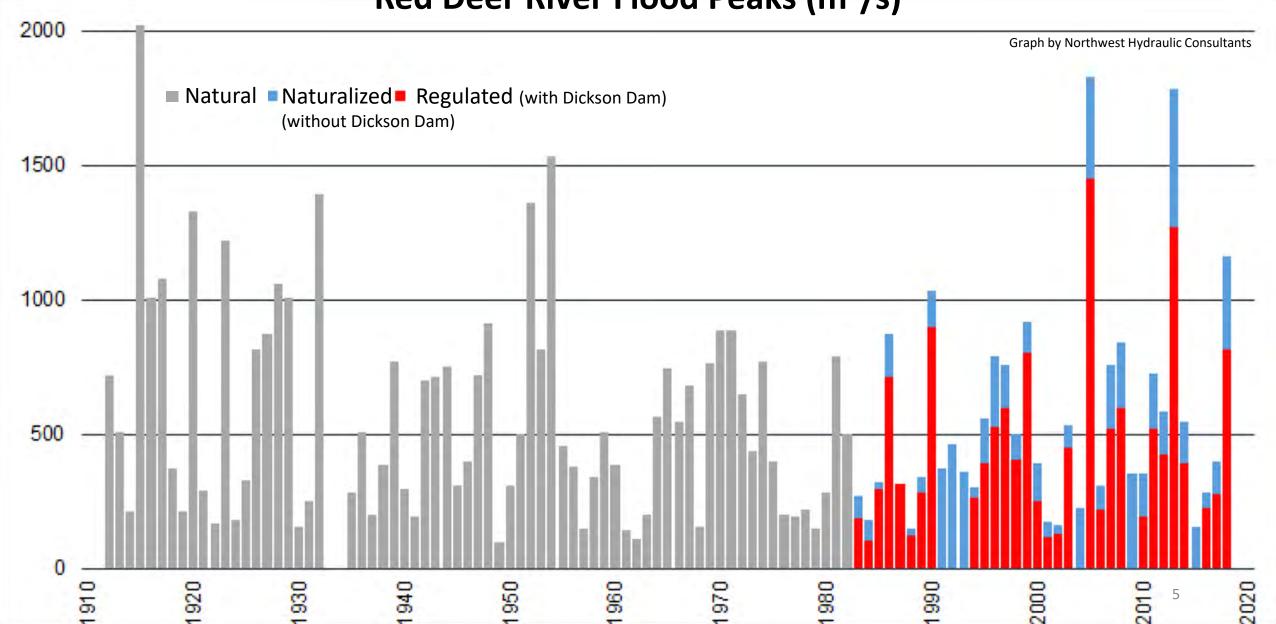
Red Deer River Flood Peaks (m³/s)

# History of Flooding - Dickson Dam Storage

- Recent flooding occurred in 2005 with a peak of 1450m<sup>3</sup>/s and 2013 at 1230m<sup>3</sup>/s
- 2013 Provincial exemption development regulations to the regulated 100-year flood level
- New regulatory and berm design flow rate set in 2021 is 1850m<sup>3</sup>/s

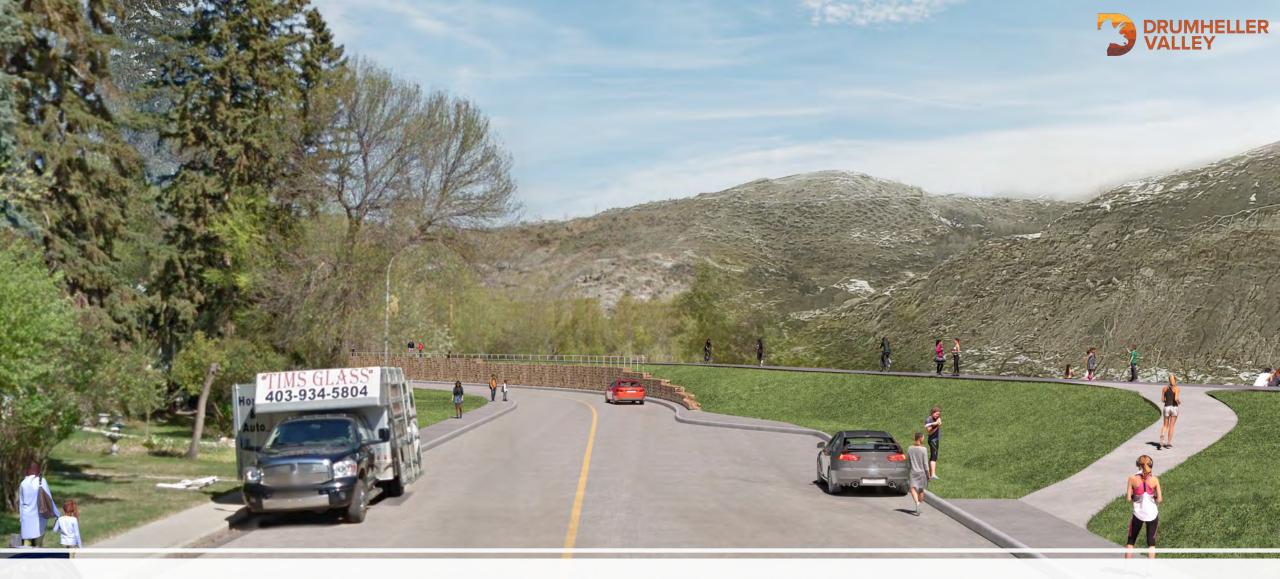
Riverside Drive – Rendering of Retaining Wall – Looking North

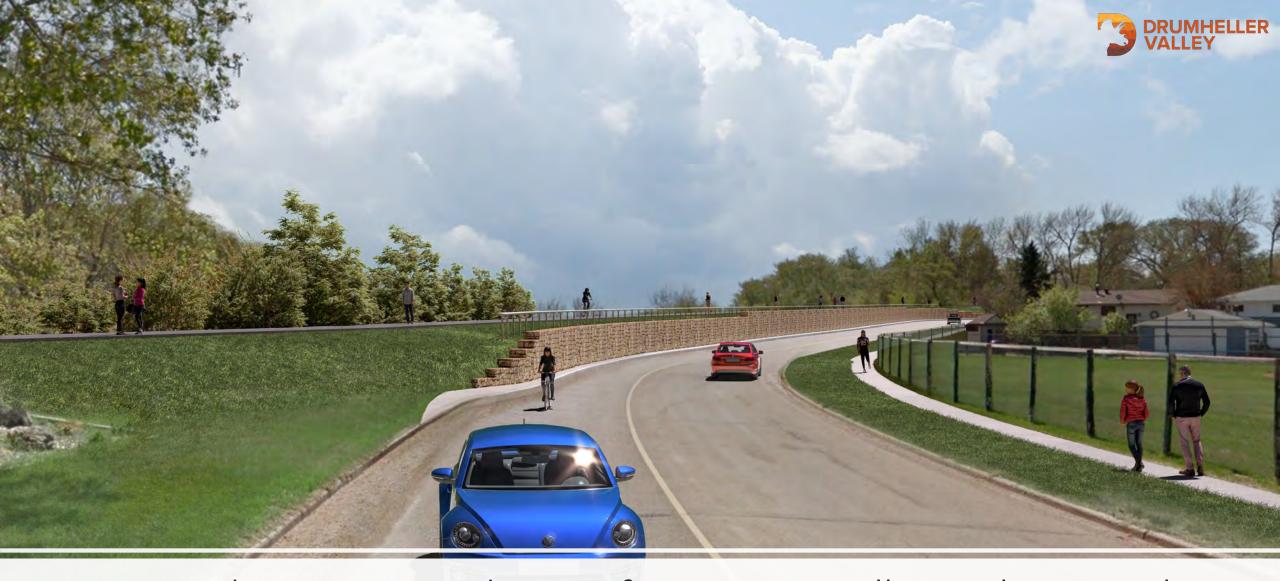
Riverside Drive – Rendering of Retaining Wall – Looking South

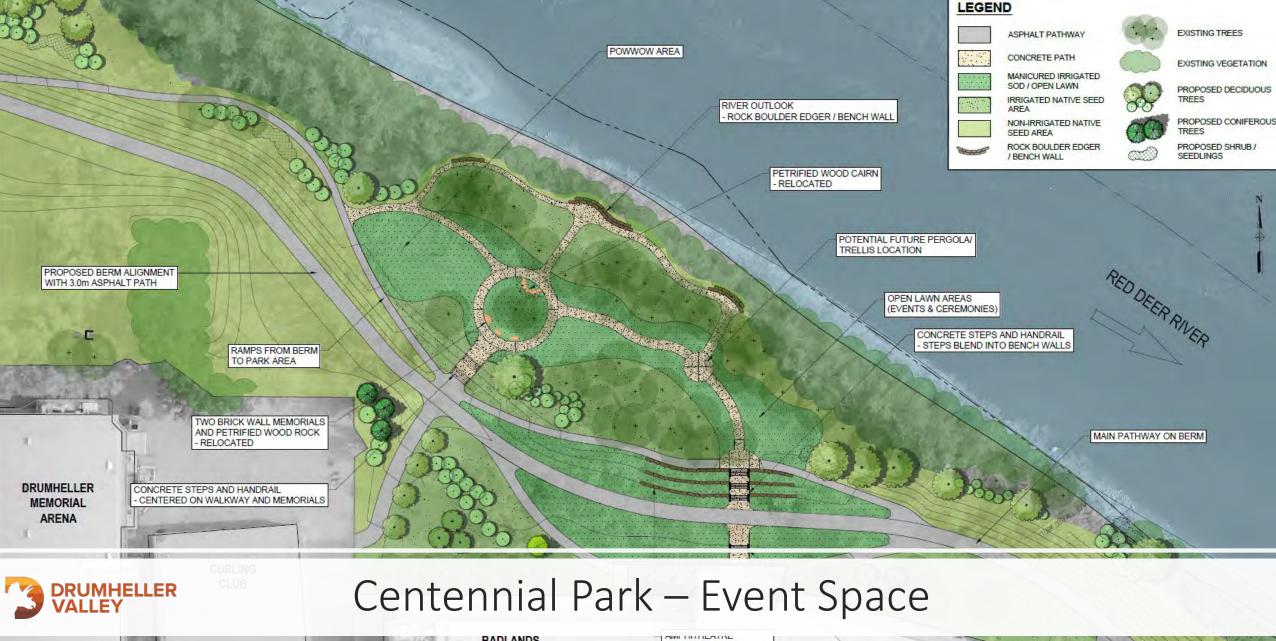
COMMUNITY FACILITY

WALLS BUILT OUTSIDE THE BERM STRUCTURE

CONCRETE STEPS AND HANDRAIL AT MAIN ENTRY

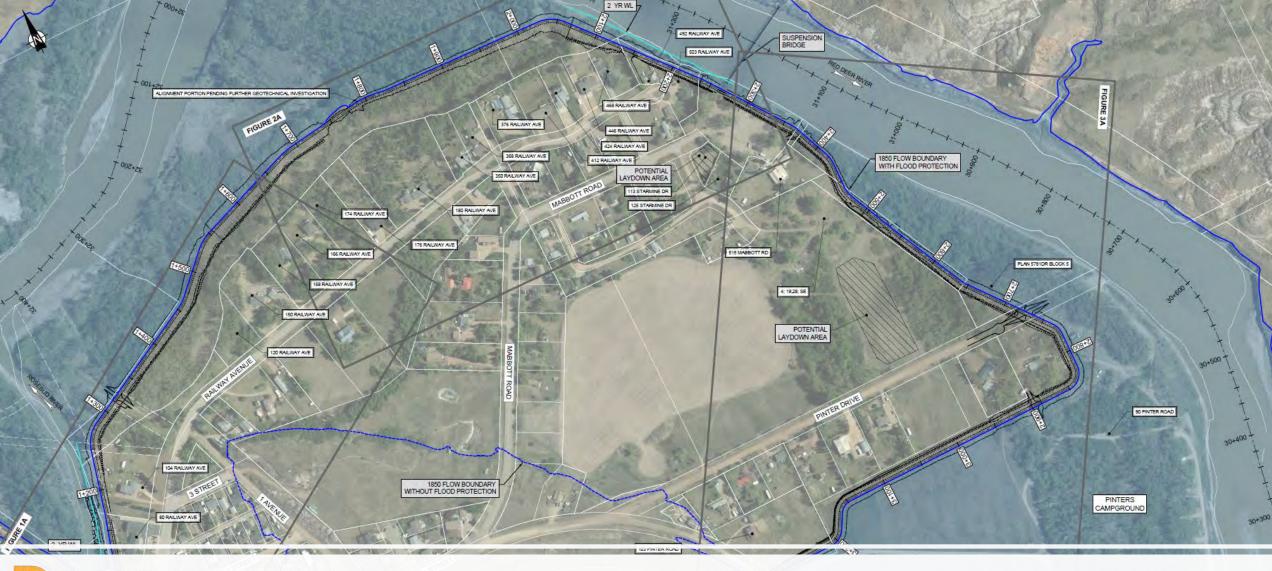
Rosedale Berm - Overall Site Plan

# **Typical Berm Cross-Sections at Rosedale Berm**

Typical Cross Section along the Rosebud River HYDROSEED/HYDROMULCH OVER TOPSOIL (100 THK) 500 FREEBOARD-2 YEAR WI TOPSOIL (100 THK) CLASS 2 RIPRAP 800 THK MIN. OVER ARMOUR GRAVEL 300 MIN. OVER EXISTING GROUND LOW TO MEDIUM PLASTICITY CLAY (SEE NOTE 1) Typical Cross Section along Red Deer River - EXISTING GROUND 200 mm TOPSOL STRIPPING (SEE NOTE 1)
